Maine Turnpike Authority

2016 Annual Inspection

**Maine Turnpike Annual Inspection
2016**

Inspection Field Report
Prepared by: HNTB Corporation

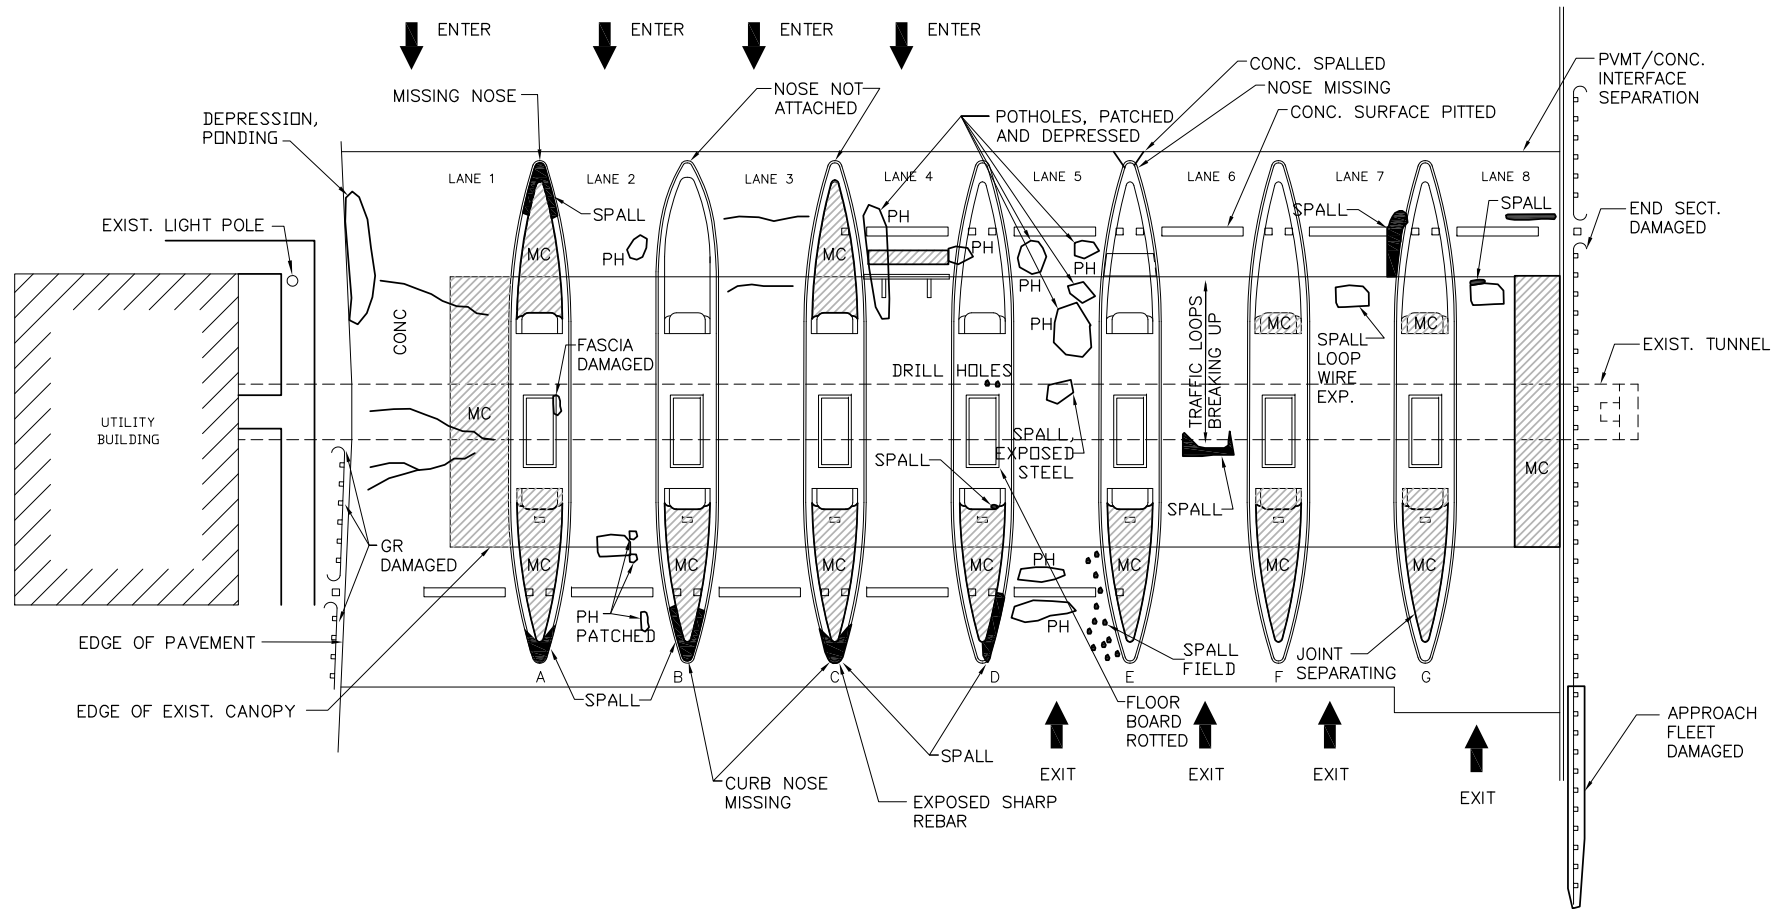
PLAZA
7. UNDERSIDE OF CANOPY RUSTED AND PEELING PAINT
DEBRIS BUILD UP & RUSTING AT BOT. OF CONDUITS
ON ISL'S (TYP FOR ALL)
MOST DOOR FRAMES RUSTED AT BOTTOM

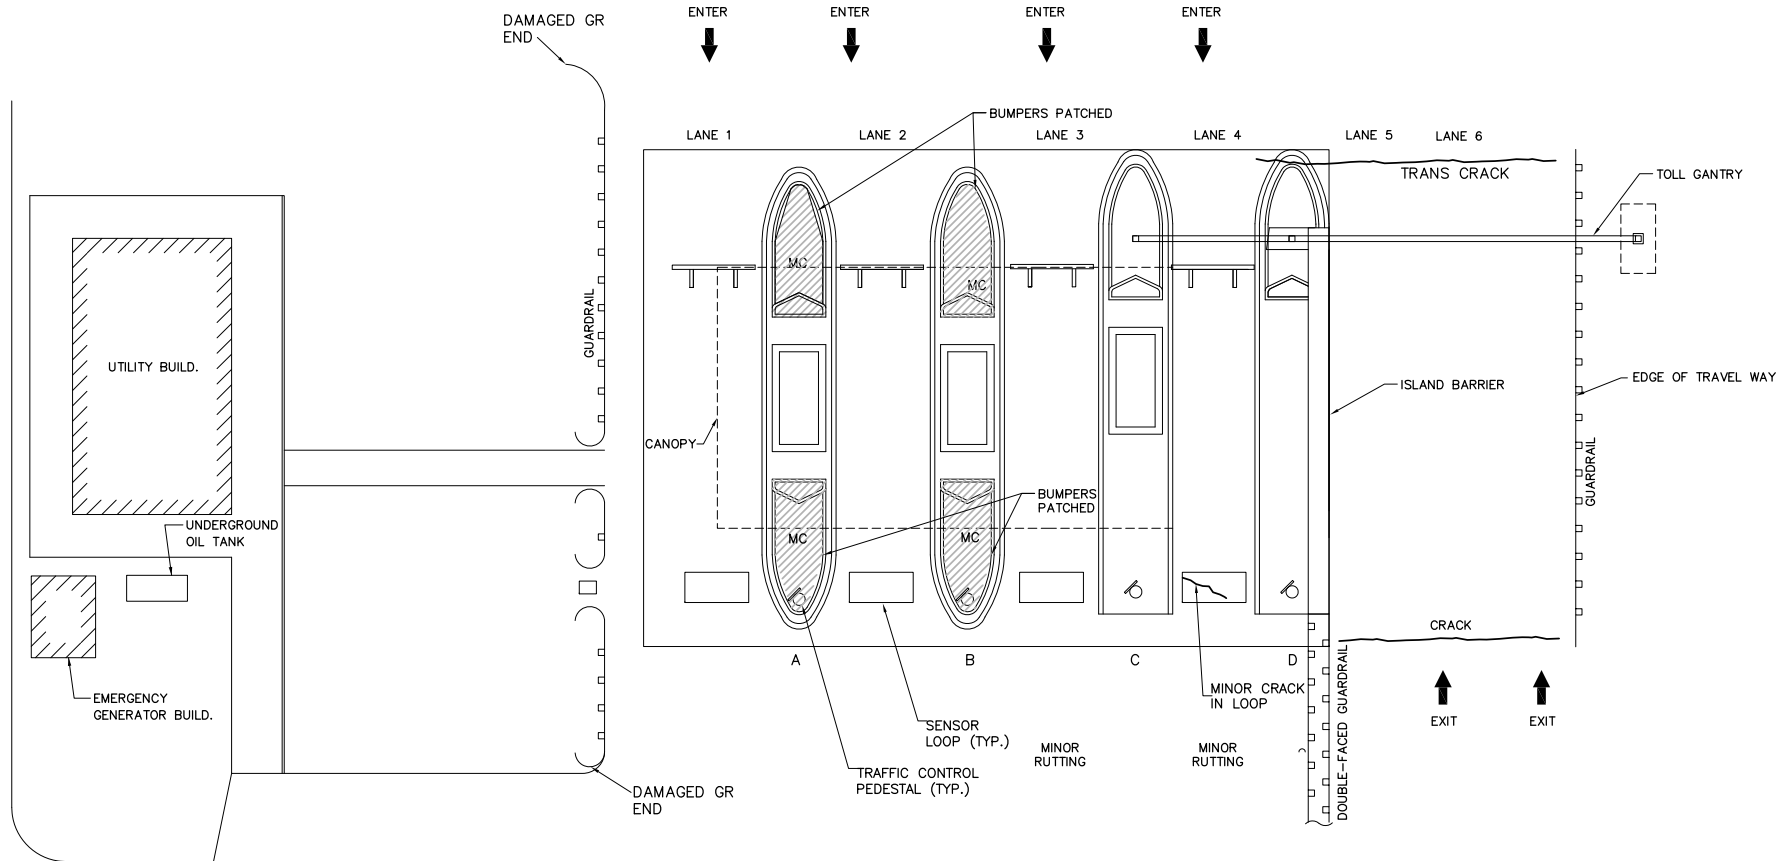
A & B BOOTH DOOR
FRAMES RUSTED

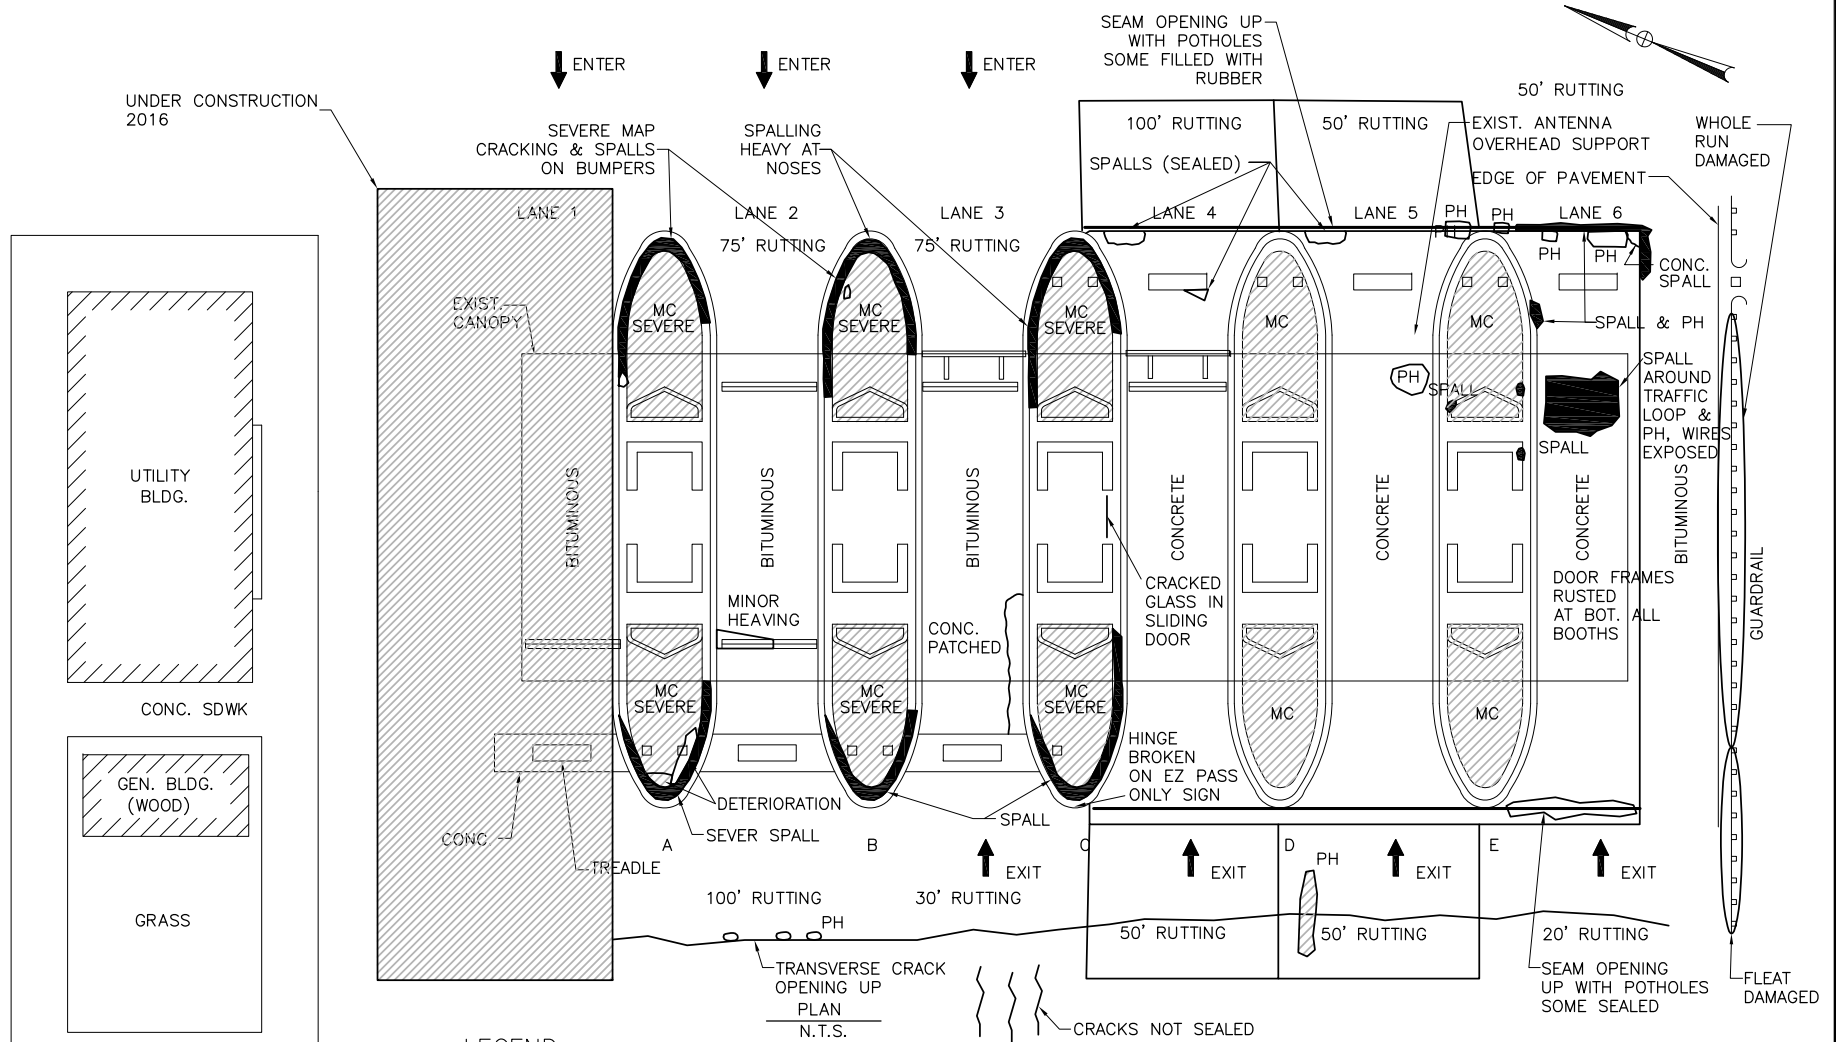
PLAZA
7. PEELING PAINT/RUSTING UNDERSIDE OF CANOPY
ALL JUNCTION BOXES ON CANOPY COL'S RUSTED

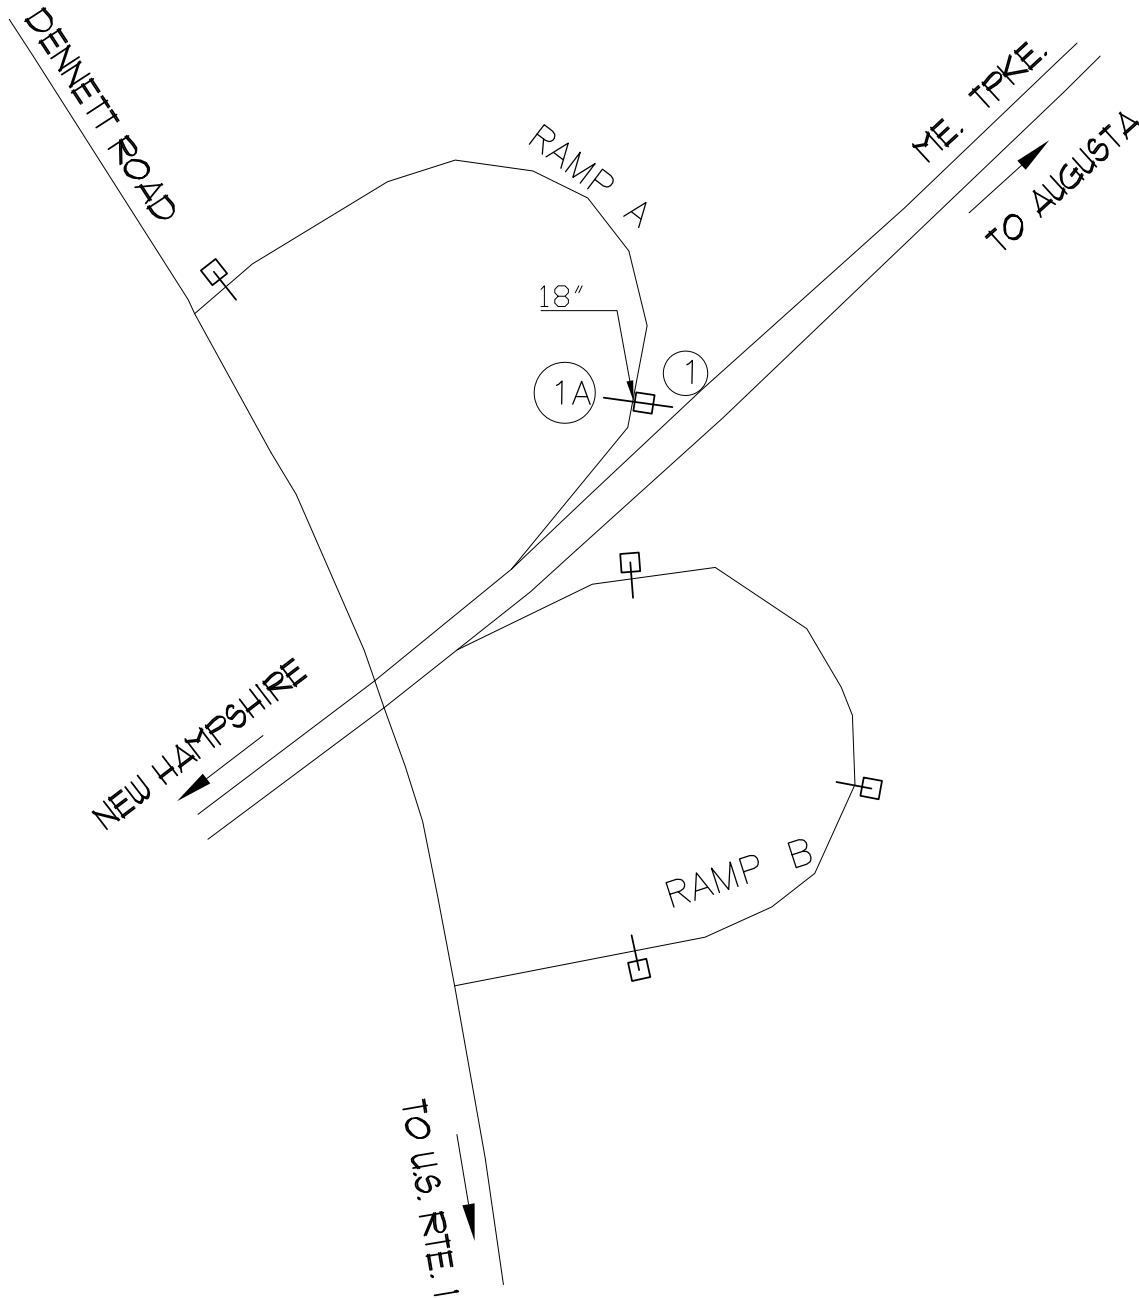
Minor spall on pipe end w/ exp. reinforcement. Inlet to CB, no flow. Some debris in barrel. CB is settling.

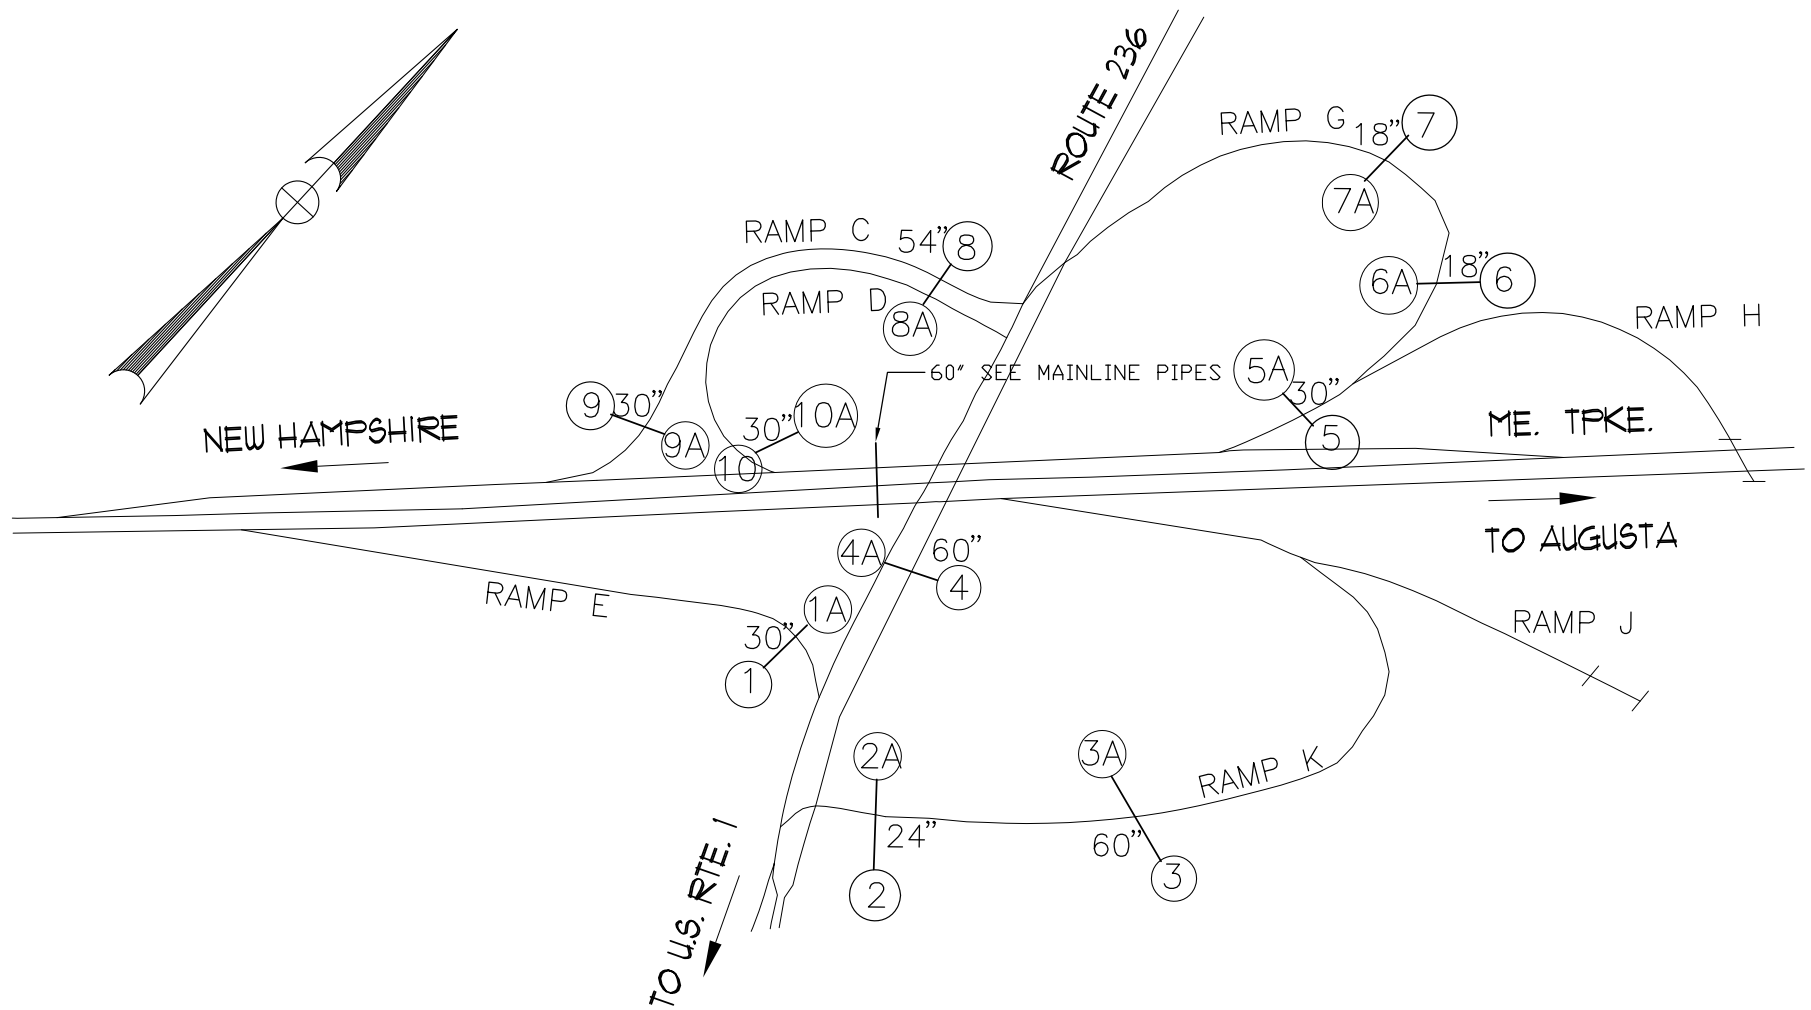
Maine Turnpike Authority Maine Turnpike	
	INTERCHANGE PIPE CULVERTS ROUTE 236 KITTERY EXIT 2/3
	HNTB Engineers Architects Planners
Contract 2016	Sheet No. 1 of 1

Exposed reinforcement on pipe rim. Outlet from DI.
