### Drainage Culvert Repairs

### Crack Sealing

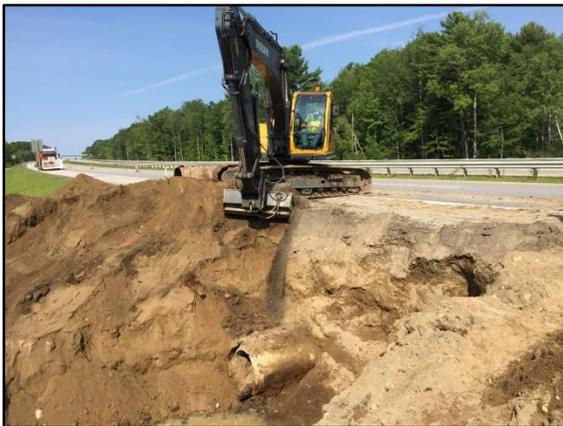
*Excavating and removing the old pipe ends.*

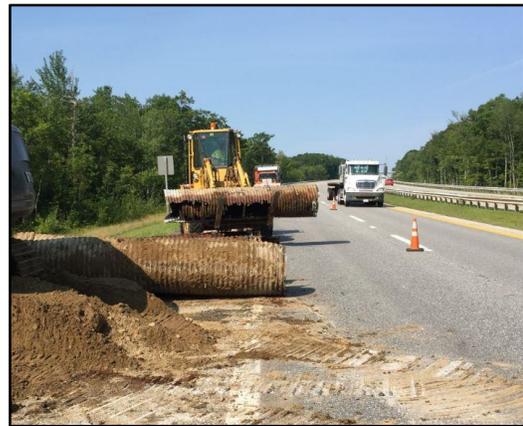
*Old pipe removed. Note rotted-out invert.*
