Exit 75 Transportation Study

Phase I Report

Short Term Transportation Needs

Maine Turnpike Authority

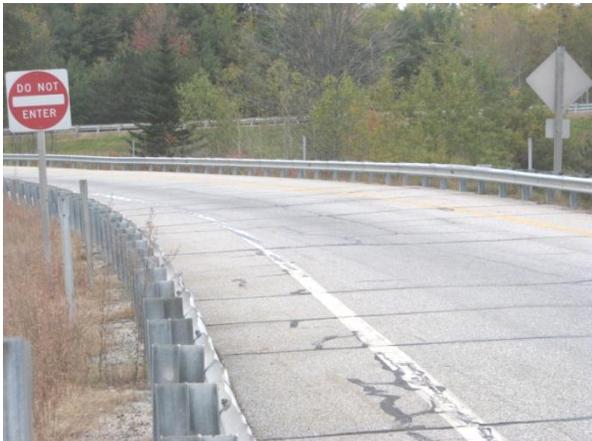
The ramps were repaved in 1993 and the acceleration lanes adjacent to the mainline were paved in 2006 during the Turnpike mainline paving. The assessment of the ramp pavement ranges from a “generally fair” condition to a “generally good” condition. Both NB and SB on ramps and acceleration lanes have a “fair” condition; both NB and SB off-ramps and their deceleration lanes have a “generally good” condition. Pavement between the mainline bridge and the Route 202/4/100 intersection is in a “generally fair” condition. This pavement has aged considerably with transverse, longitudinal and map cracking, and several patched pot holes. The MTA has an ongoing program to crack seal, patch, and overlay sections of the pavement as warranted. Figures 2-6 show images of this section of roadway.

**Figure 2 – Northbound off-ramp towards traffic
(Note crack sealing)**

Pavement rehabilitation of all ramps is needed. Partial depth pavement re-construction may be required from the merge area of the off-ramps to the Route 202/4/100 intersection, including the separated right turn lanes leading to and from the ramps, to improve pavement condition and extend life beyond that of an overlay.

- Pavement rehabilitation of all ramps is needed. Partial depth pavement re-construction may be required from the merge area of the off-ramps to the Route 202/4/100 intersection, including both slip lanes, to improve pavement condition and extend life beyond that of an overlay.

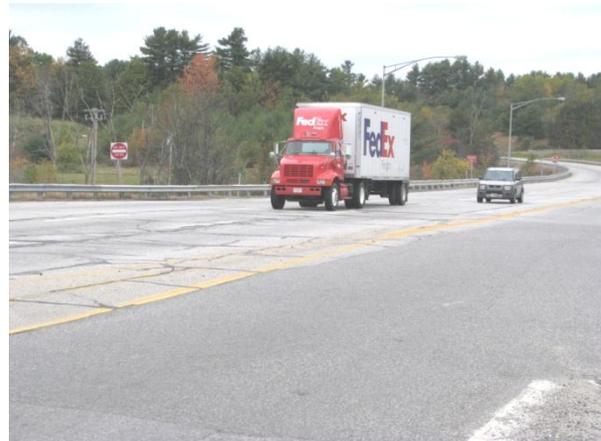
**Figure 3 –NB & SB off-ramps approaching Route
202/4/100 intersection
(Note crack sealing for Turnpike exiting lanes and
overlay for entering lanes)**

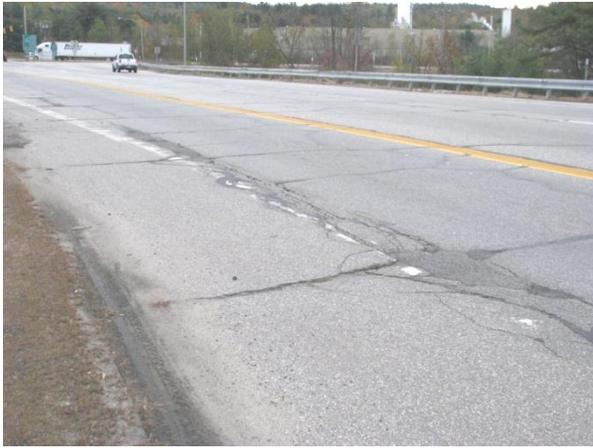
Figure 4 – Looking at Route 202/4/100 intersection from Turnpike approach
(Note significant crack sealing, large cracks and patched pothole)

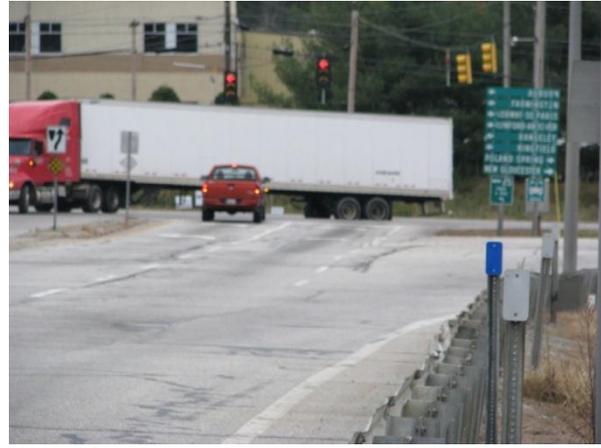
Figure 5 - Turnpike approach to the Route 202/4/100 intersection
(Note extent of cracking)

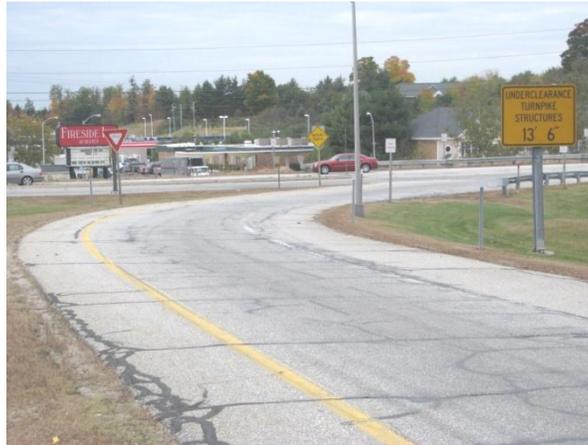
Figure 6 - Right slip lane onto on ramps from Route 202/4/100 southbound
(Note significant crack sealing and large cracks)

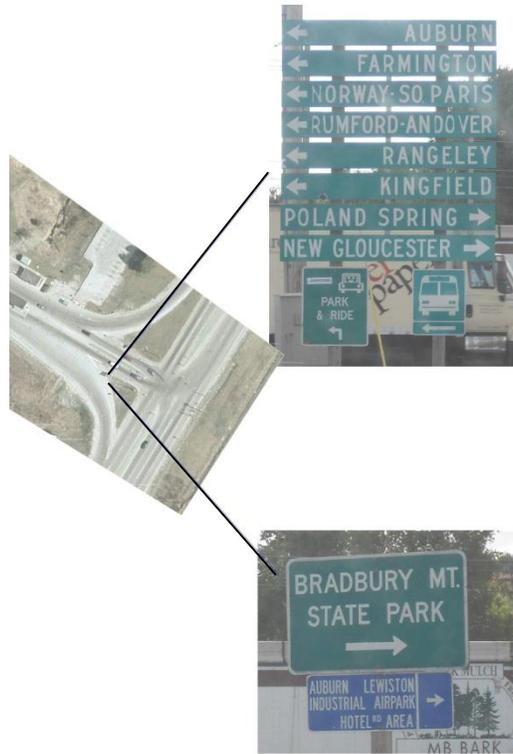
Figure 8 - Exit 75 off-ramp - Signing at center island

The Park & Ride sign on the traffic island is similar to, but not quite an MUTCD standard sign, it also has been vandalized (with a sticker). It should be replaced with a standard Park & Ride sign (see Figure 11) with an appropriate arrow designation.

- The local attraction signs currently mounted across Route 202/4/100 should be moved to the traffic island.
- Make room for the local attraction signs by removing the large green/white directional sign. The eight panel sign is not compliant with the MUTCD, is not in an ideal location, and is easily overlooked.

- The current Park & Ride sign and airport sign should be replaced with standard signing.
- Rumble strips were not detected at the off-ramp during a field visit. It is therefore recommended that the warning signs for rumble strips be removed.

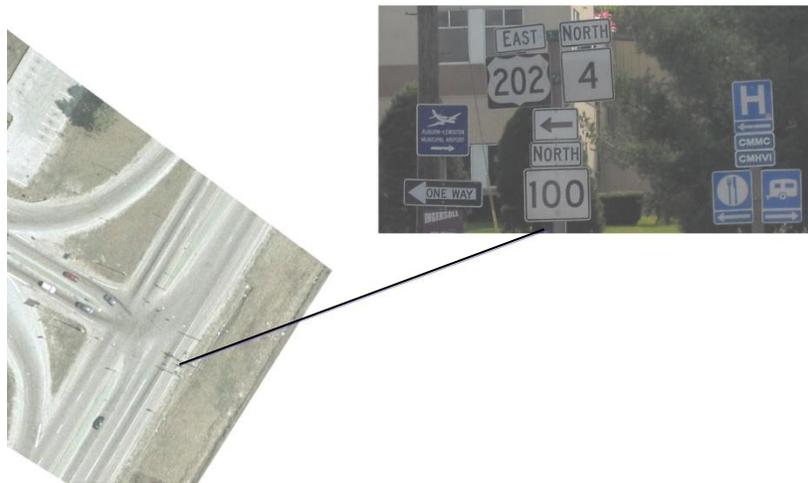
Figure 9 - Exit 75 off-ramp - Signing opposite Route 202/4/100

The large green/white directional assembly does not meet the current guidelines of the Manual on Uniform Traffic Control Devices (MUTCD). The MUTCD strongly recommends that guide signs be limited to three lines of principal legend. The current assembly has eight. The reasoning for limiting the amount of legend is that the longer the legend on a guide sign, the

longer it will take motorists to comprehend it. This sign is also located at a less than ideal location. The information on this sign is needed by the motorist *in advance* of the decision point (being the triangular island that splits left and right turns). Due to this sign's location and amount of legend, this sign is easily overlooked by motorists. An example of a more effective sign is shown in Figure 10.

The route sign assembly at the far side of the intersection on Routes 202/4/100 (also shown in Figure 9) needs arrow plaques below each route number. In addition, the MUTCD strongly recommends that an additional route sign assembly be placed at 400' from the decision point with every directional plaque and arrow plaque in order to pre-position vehicles in the correct lanes.

Several of the local attraction signs that are on the far side of the intersection shown in Figure 9 should be moved to the traffic island where they will better provide timely information. The signs for the hospital, food, and trailer camping should be visible to motorists before they make a decision on whether to go left or right. The sign for the airport is not a standard sign and should be replaced with a standard airport sign (see Figure 12) and moved to the traffic island. However moving these signs to the traffic island becomes difficult with the large green/white directional assembly in place. Because the directional assembly is not compliant with the MUTCD, is not in

an ideal location, and is easily overlooked due to information overload on the part of the motorist – it is recommended that it be removed.

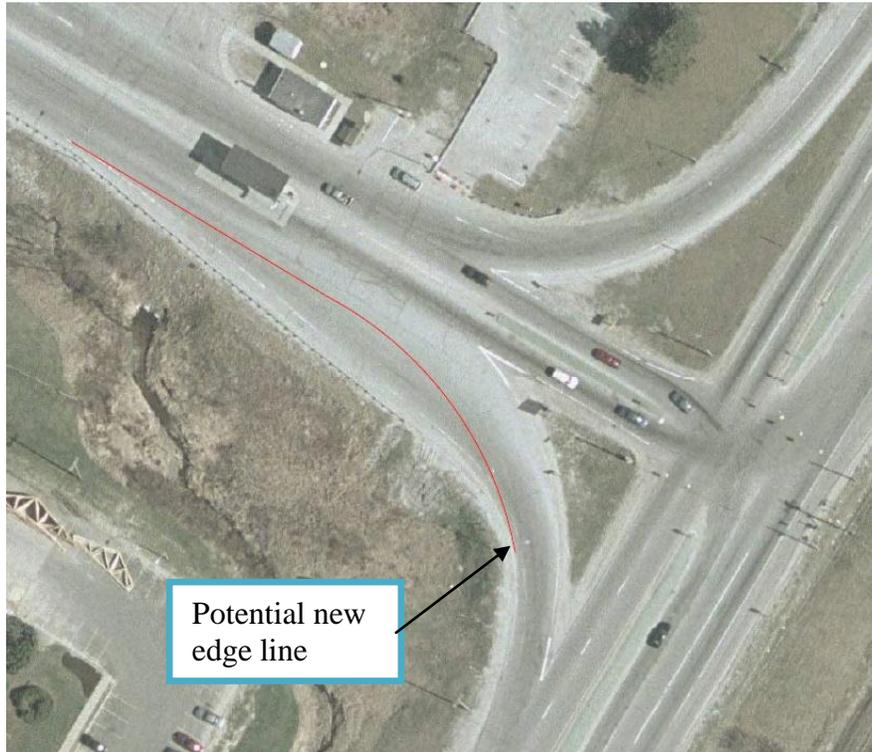
Figure 16 - Proposed Pavement Marking Change

Also, a change to the placement of the outside lane line on the off-ramp where the right turn splits off from the left turning traffic could improve the decision/weaving distance for traffic coming off the Turnpike headed for Route 202/4/100. Essentially, the change would involve a narrowing of the neck of the ramps at the triangular island as shown in Figure 16. Currently, northbound off-ramp traffic is not required to weave because they can access both the right turn and left turn onto Route 202/4/100 from the right lane. Southbound off-ramp traffic has to weave to get to the right turn lane onto Route 202/4/100. The weaving movement becomes difficult because of the large amount of pavement available for the right turn. Performing the weaving movement can effectively require two lane changes because of the width of the pavement. Reducing the width of pavement for the right turn would create more definition of lanes and more order.

Such a change would not have an adverse impact on traffic capacity of the intersection as long as it was placed at a point that the left-turning vehicle queues would not block the entrance to the right turn split. This change would be relatively easy to implement, could increase the weaving

and decision distance from 210 feet to 370 feet, and if combined with a corresponding move of the guardrail, would also provide a more visible place to put a new guide sign.

- A new MUTCD compliant destination guide sign and route sign assembly should be added to the off-ramps.
- Reduce the width of pavement for the right turn lane by moving guardrail and restriping. This will also provide a more visible place to put the new guide sign.

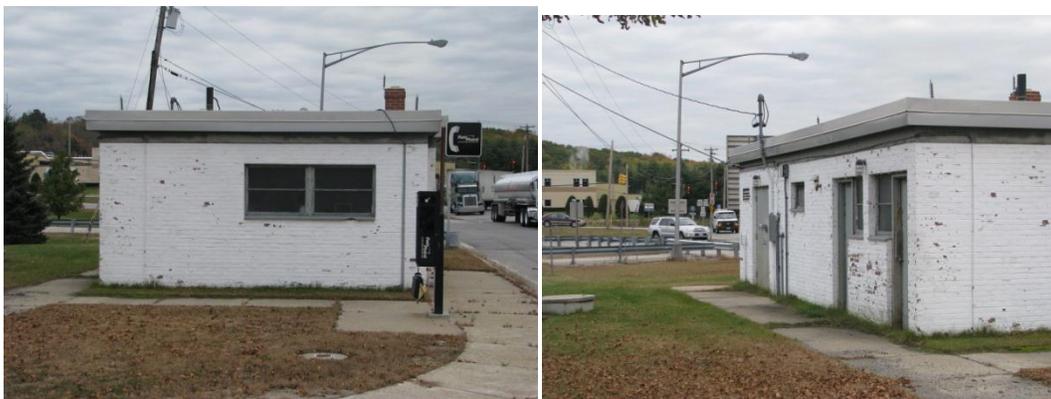
Figure 17 – Old toll building at Exit 75

Exit 75 had a toll plaza until its removal in 1999. However, when the toll plaza was removed, not only did the extra pavement remain in place, but also a utility building on the northern side of the approach to Route 202/4/100. This building has a less than ideal appearance. Figure 17 shows the exterior of the building as seen by motorists.

The building's primary purpose at this time is to house the electrical panels/disconnects for the plaza lighting. It is recommended that the building be removed and replaced with a utility cabinet unless the MTA decides to implement full ETC on the northern end. Removal of this building would also reduce maintenance costs.

- Consider removing the utility building and replace with a utility cabinet or similar structure.

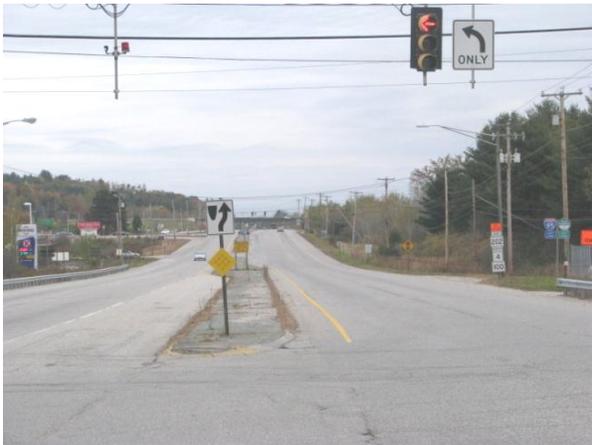
HNTB staff observed the pavement on the section of Route 202/4/100 in the study area. Using the same rating methods as the MTA’s annual inspection, this section of Route 202/4/100 pavement was categorized as being in “fair condition”. There is consistent cracking, (longitudinal, transverse and map cracking) throughout the roadway corridor. The roadway is divided with a median that is either grassed or paved. The paved median has cracking with vegetation. See Figures 20 through 22 for images of the typical pavement condition within this corridor.

Figure 20 - Kitty Hawk Ave. intersection looking north toward Turnpike intersection

Improvements recommended for Route 202/4/100 are a pavement overlay and re-striping from the Maine Turnpike Overpass to Kittyhawk Ave. MaineDOT should consider extending the limits of an overlay through the entire section of focused study area on Route 202/4/100.

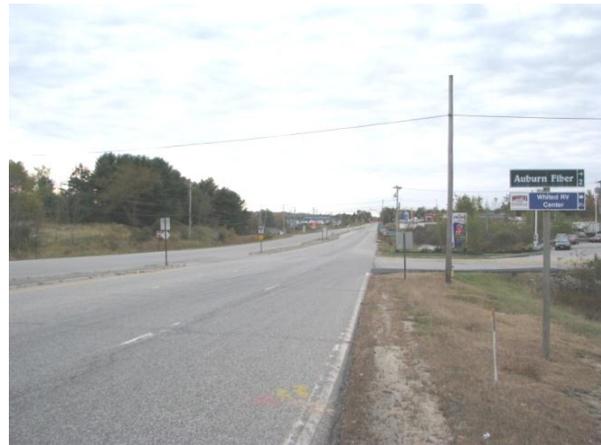
**Figure 21 – Turnpike intersection looking south toward Kitty Hawk Ave. intersection
(Note entrance to Irving gas station on right)**

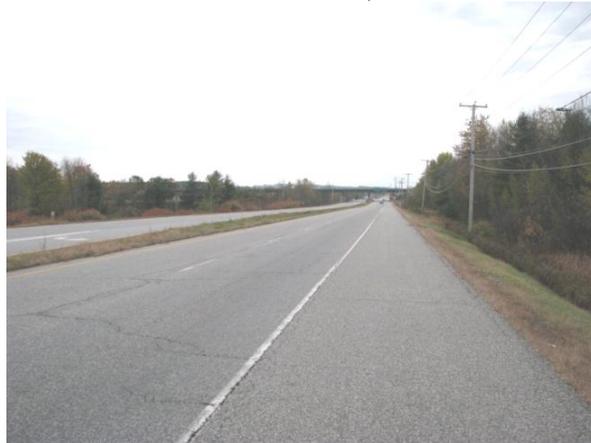
Figure 22 – Danville Corner Road/Beech Hill Road intersection looking south toward Turnpike

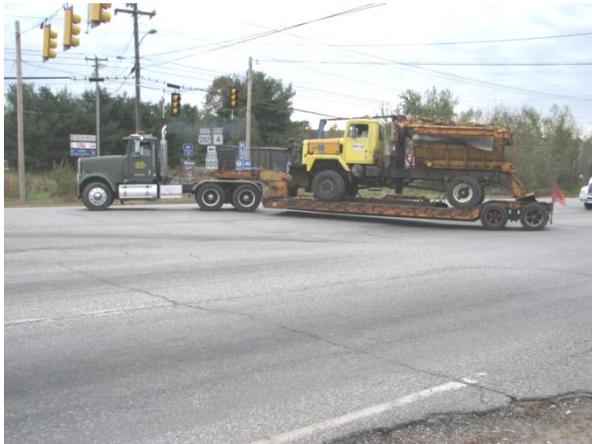
Pavement at the intersection with the Exit 75 ramps was observed by HNTB staff to be in “marginal condition”. Rutting and shoving were observed and there is significant pavement

degradation in the median between the NB and SB Route 202/4/100 traffic. The double crown for both directions of Route 202/4/100 causes turning heavy vehicles to bounce even at moderate speeds (see Figure 23). Another issue at the intersection is the northbound left turn lane from Route 202/4/100 onto the Turnpike (see Figure 24). There is noticeable pavement shoving, rutting and cracking throughout this lane making the turning movement slow and difficult which is due in part to the “bouncing” vehicles as well as the constant stopping, queuing, and starting movements typically experienced at intersections.

Figure 23 - Exit 75 Intersection Left turn onto Route 202/4/100. (Note: Dip below truck bed)

- Pavement overlay and re-striping along Route 202/4/100 from the Maine Turnpike Overpass to Kittyhawk Ave. MaineDOT should consider extending the limits of an overlay through the entire section of focused study area on Route 202/4/100.
- An advance entrance direction sign would be beneficial for the northbound traffic. This sign would be similar to the sign for the Route202/4/100 southbound lanes
- During the next scheduled restriping, it is suggested that arrow pavement markings be placed within the approach lanes. Left turning and through arrows as well as ‘ONLY’ markings for the left turn lane would add clarity to the approaches to the intersection.
