2021 OPERATION AND MAINTENANCE ANNUAL REPORT

PRESENTED BY: HNTB CORPORATION
PRESENTED TO: MAINE TURNPIKE AUTHORITY

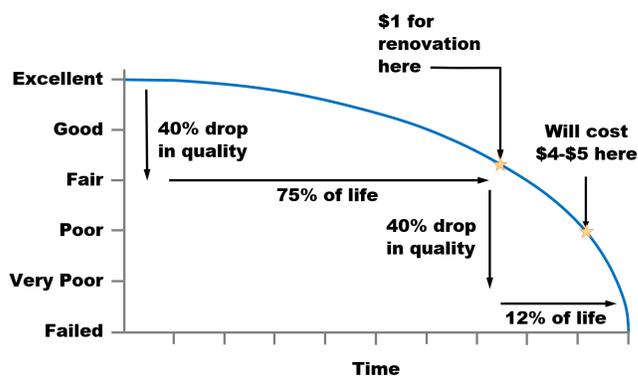
FIGURE 2: PAVEMENT LIFE CYCLE

FIGURE 2 illustrates the rate of deterioration and relative cost of rehabilitation at various times throughout the Life Cycle of a section of pavement. Evidence that pavement requires rehabilitation includes wheel rutting, excessive cracking, and poor ride quality.

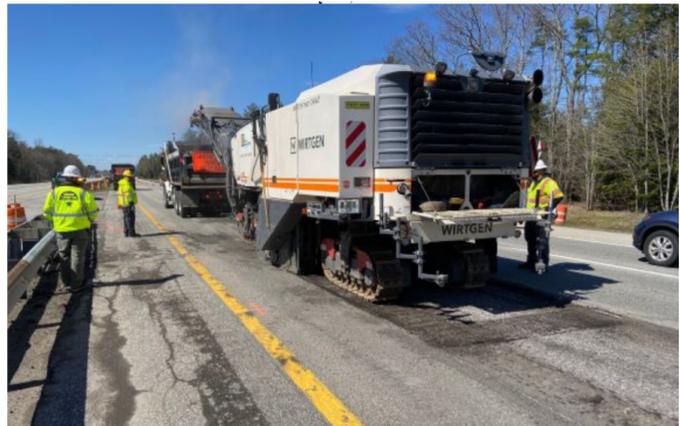
MILLING OPERATION TO PREPARE EXISTING PAVEMENT TO RECEIVE NEW PAVEMENT

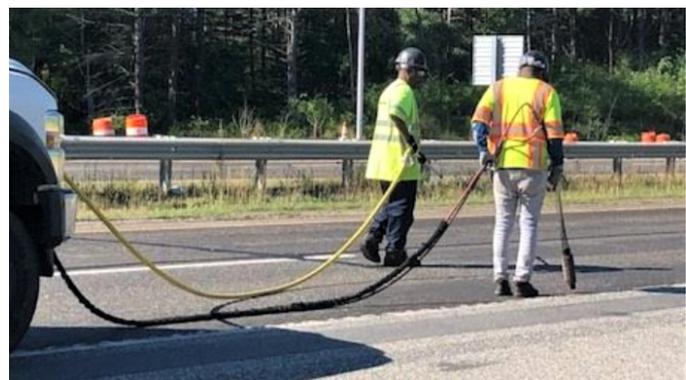
DISPENSED AT OVER 350 DEGREES THE RUBBERIZED ASPHALT SEALANT IS INJECTED DIRECTLY INTO PAVEMENT CRACKS DURING CRACK REPAIRS

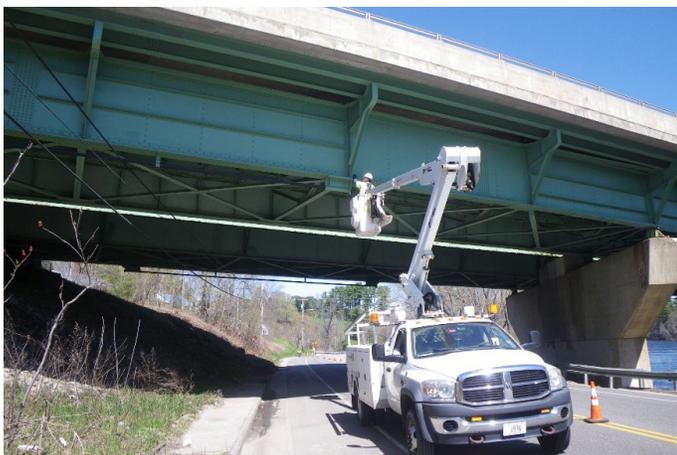
HANDS-ON INSPECTION OF THE ANDROSCOGGIN RIVER BRIDGE

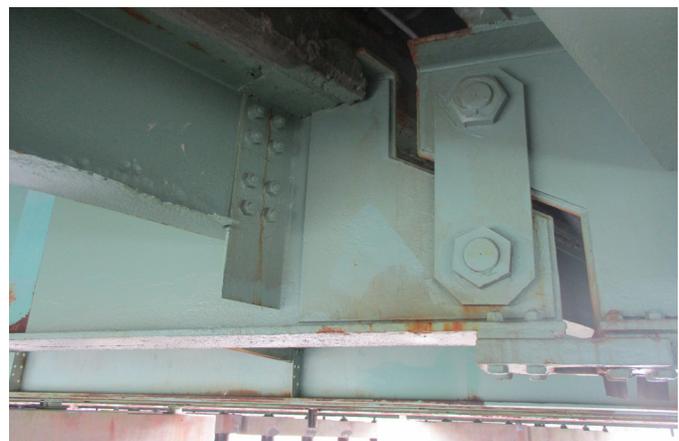
At the York River Bridges, the girder framing system includes pin-and-link assemblies. Because routine inspection procedures are insufficient to identify defects in the pins, ultrasonic testing of these elements is necessary. A five-year inspection frequency for ultrasonic testing is suggested. This frequency is based on engineering judgement since the FHWA does not have a required frequency for these components.

PIN-AND-LINK ASSEMBLY AT THE YORK RIVER BRIDGE

The first detailed inspection and ultrasonic testing of the pin-and-link systems at the York River Bridges was completed in December 2011. No serious structural deficiencies were noted during the inspection. The next detailed inspection was scheduled for 2016. However, a 2015 rehabilitation contract involved disassembling, reassembling, and painting the pin-and-link assemblies. This work was considered an acceptable detailed inspection procedure and, therefore, ultrasonic testing was not performed in 2016. The most recent detailed inspection was completed in the fall of 2020. The ultrasonic testing concluded the pin-and-link assemblies remain in good condition. No serious deficiencies were found. The next detailed inspection is scheduled for 2025.

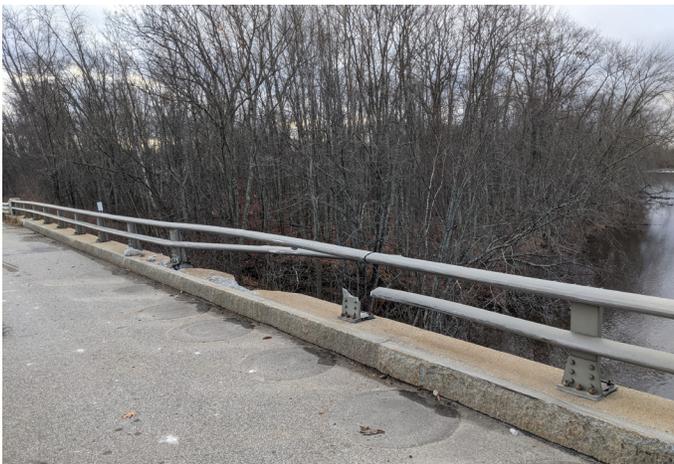
The bridge rail of the Saco River Overpass (SB) at Mile 33.01 was struck by a vehicle in November of 2020. HNTB conducted a special inspection and concluded the damaged rail, rail post and concrete curb required replacement. Temporary concrete barrier was installed along the section of damaged bridge rail. HNTB prepared contract documents for the work and a contractor completed the necessary repairs in early 2021, restoring the crashworthiness of the bridge rail system.

SACO RIVER OVERPASS DAMAGED BRIDGE RAIL

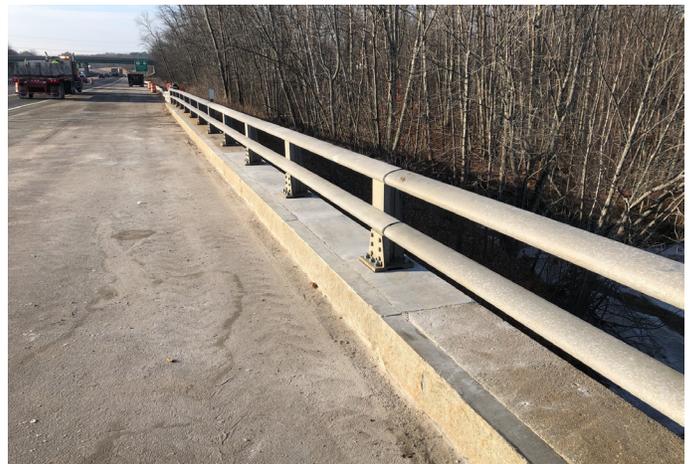
SACO RIVER OVERPASS REPAIRED BRIDGE RAIL

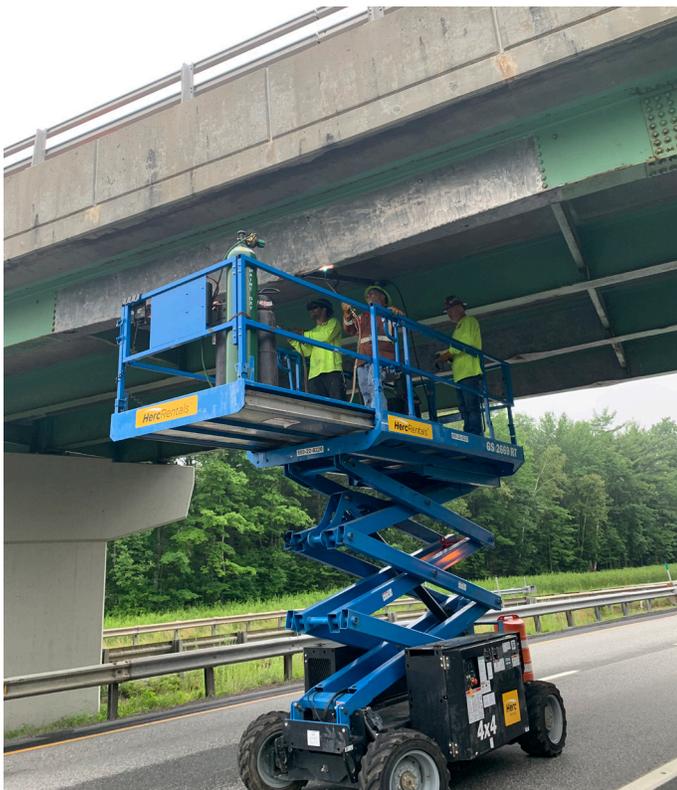
The Grove Street Underpass at Mile 83.7 was struck by an unknown overheight vehicle in February of 2021. HNTB conducted a special inspection and concluded structural repairs were required. Along the south fascia girder, the damage required heat straightening and replacement of a 5-foot section of the girder bottom flange. Two additional girders required heat straightening to repair areas of girder deformation. Following the accident, the south shoulder of the bridge was closed to reduce loads on the south fascia girder to acceptable levels. HNTB prepared contract documents for the work and a contractor completed the necessary repairs in August 2021.

GROVE STREET UNDERPASS, MILE 83.7

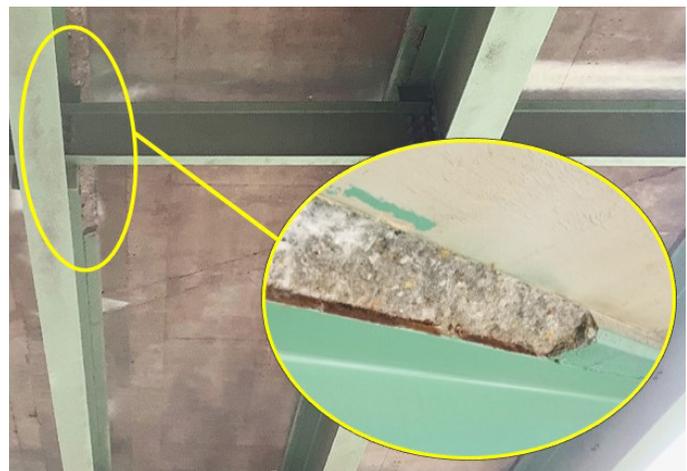
An evaluation of the underside of Turnpike bridge decks was commenced in 2021 to assess portions of concrete decks adjacent to bridge girders. On many Turnpike bridges built before the mid-2000s, the deck steps downward along the edges of each bridge girder, a detail that was commonly used by bridge owners throughout the region. Agencies have since determined these unreinforced sections of the concrete deck, referred to as "unreinforced haunches", are prone to premature cracking and deterioration. In some instances, portions of the concrete haunch have fallen from Turnpike bridges onto the roadway below. HNTB, working together with Turnpike staff,

LEIGHTON ROAD UNREINFORCED HAUNCH SPALLS

identified Turnpike owned bridges with this detail and prioritized the resulting list for inspection by Turnpike maintenance forces. These inspections are ongoing and, when loose or deteriorated concrete haunches are found, they are removed. A program for addressing unreinforced haunches will be developed following the completion of the Turnpike's inspection efforts. The resulting program may include measures such as periodic hands-on inspections or the installation of netting or shielding.

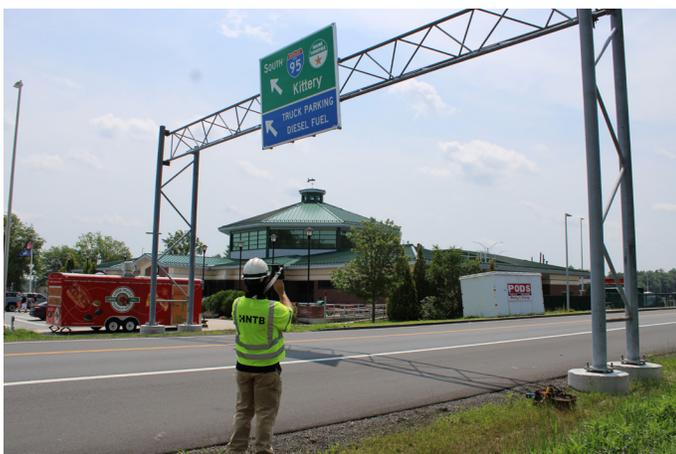
OVERHEAD SIGN STRUCTURE INSPECTION

The continuation of annual routine inspections is recommended. Additionally, we recommend the next hands-on inspection cycle for all overhead sign structures occur in 2026. This recommendation is consistent with the FHWA guidance that a typical two tower, two or four post sign bridge with a steel superstructure, be hands-on inspected at least once every six years.

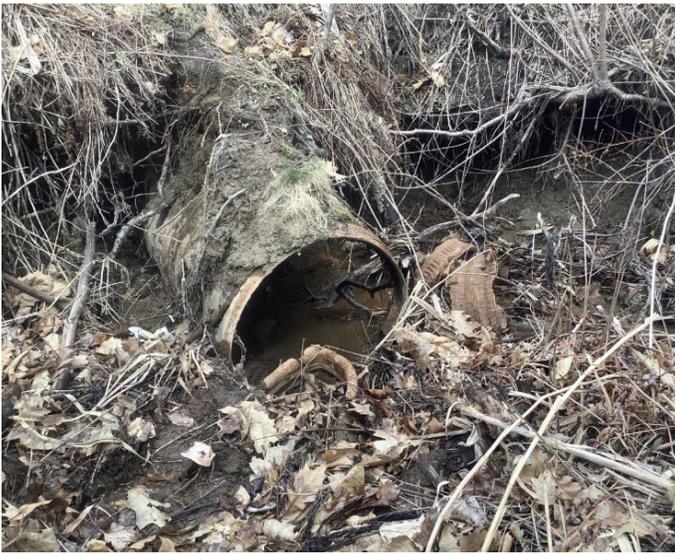
TYPICAL DETERIORATED PIPE/OUTLET

ture, such as slope failures and sinkholes. A total of 28 circular culvert end locations, and two single-cell concrete box culverts, are in poor condition.

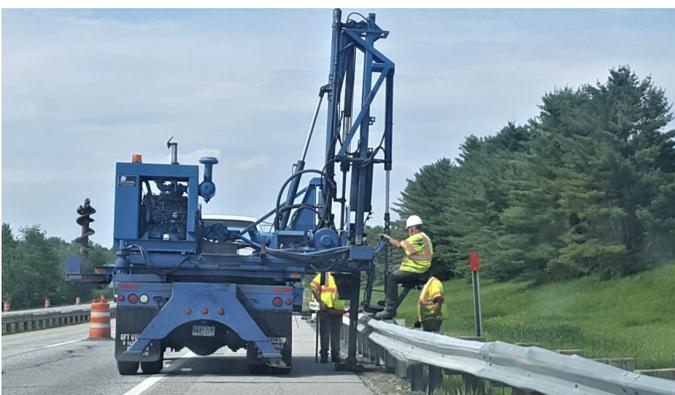
GUARDRAIL UPGRADES

A program to upgrade and modernize Maine Turnpike guardrail on an as-needed basis has been in place since the mid-90s and remains active. This program includes the following:

- » Installation of thrie beam guardrail or median concrete barrier at select locations;
- » Closing median openings that are not critical for authorized vehicles;

- » Constructing new median openings at areas with adequate sight distance;
- » Installing Emergency Vehicle Ramps to eliminate the use of median openings, or where new openings cannot be constructed;
- » Replacing non-crash attenuating guardrail terminal end sections with impact attenuating units;
- » Adjusting guardrail heights;
- » Improving strength of guardrail at locations where the guardrail was in close proximity to bridge piers;
- » Adding guardrail; and,
- » Constructing new terminal end – anchored end sections.

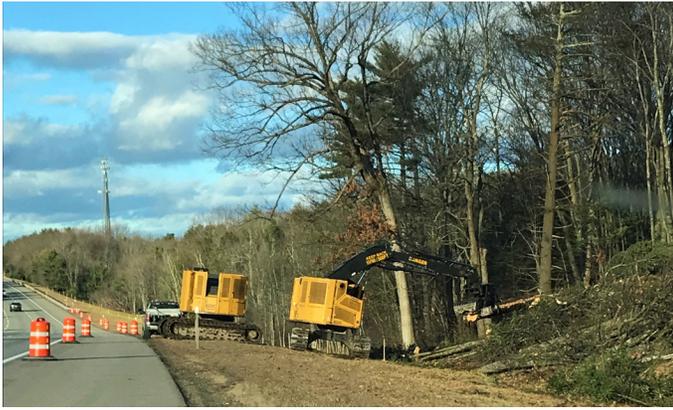
SIDE SLOPE CLEARING

When practical, Turnpike maintenance crews clear brush and small trees along the tree line to maintain the current tree line and to remove fallen and damaged trees.

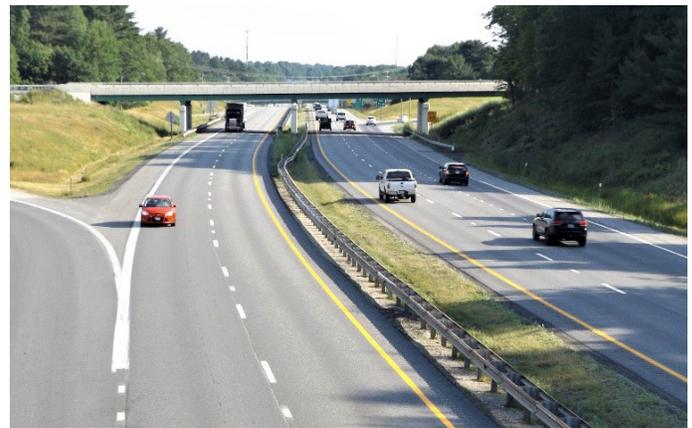
ROADWAY MARKINGS

The Authority is also utilizing reflectorized pavement marking tape installed in grooves at interchange ramps and to supplement the white skip lines on the mainline. The tape improves visibility of the pavement markings in wet conditions and at night.

Double yellow lines in two-way traffic areas within interchanges, and newly paved areas, are typically painted twice a year. This frequency has been adequate to maintain roadway striping.

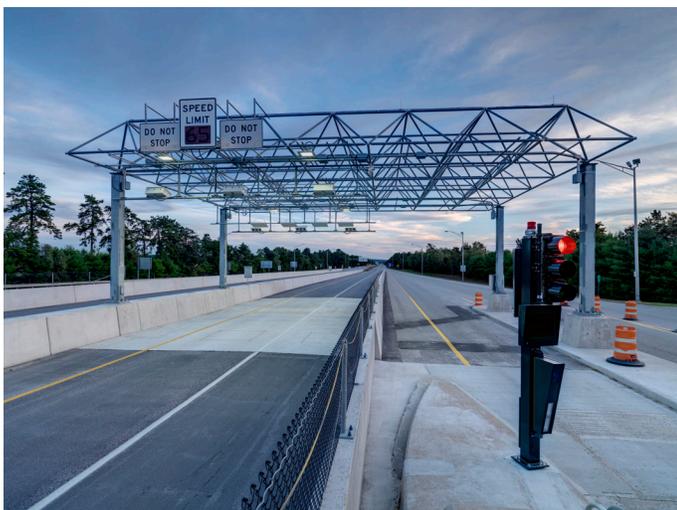
NEW GLOUCESTER TOLL PLAZA ORT, MILE 67.0

A May 2013 Toll System Assessment Report outlined that the legacy cash toll collection system installed in 2004 provides acceptable levels of performance, reliability and system uptime availability based on the originally intended functionality. However, the system is reaching the end of its anticipated life. The Authority has implemented a program of converting its legacy cash toll collection system at all toll plazas to a new toll collection system called the “Infinity System”. The Infinity System has specific infrastructure requirements such as vehicle detection loops installed in a concrete roadway slab with non-metal reinforcement. The slabs must meet specific dimensional requirements to accommodate the way the loops are embedded in the concrete slab to sense vehicles and interact with other toll collection equipment.

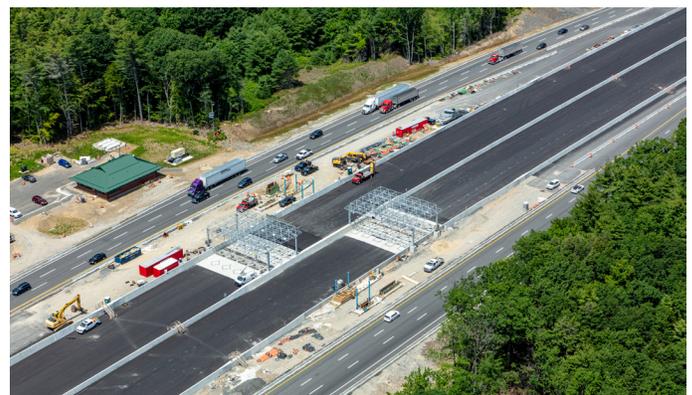
NEW YORK TOLL PLAZA

The existing York Toll Plaza, which consists of eight lanes northbound and nine southbound, was constructed in 1969 and is challenged by both operational and safety issues. The existing toll system has reached the end of its useful life and is being replaced by a new facility approximately 1-mile to the north. This plaza, which is in generally poor condition, is scheduled for decommissioning and demolition beginning in September of 2021.

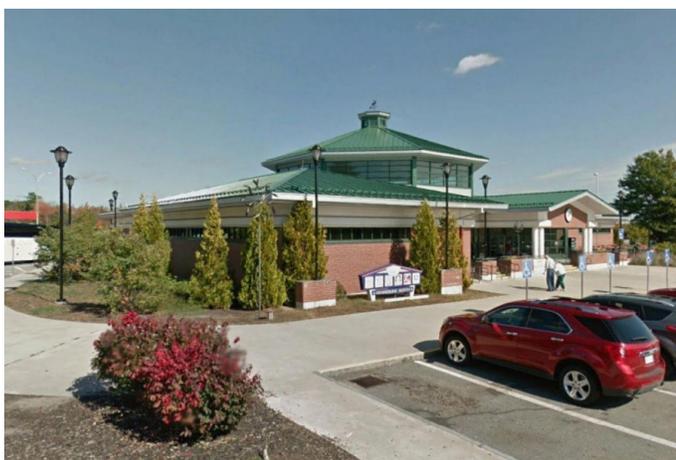
KENNEBUNK NB SERVICE PLAZA

Aside from the entryways, the existing service plazas have a range of maintenance repair needs that should be addressed to preserve the infrastructure in their current condition; all are captured in the 2021 Building Maintenance Item Summary prepared and submitted by HNTB.

The construction improvements to the Kennebunk service plazas and fuel system upgrades at the Gray facility have addressed the most pressing needs at each location.

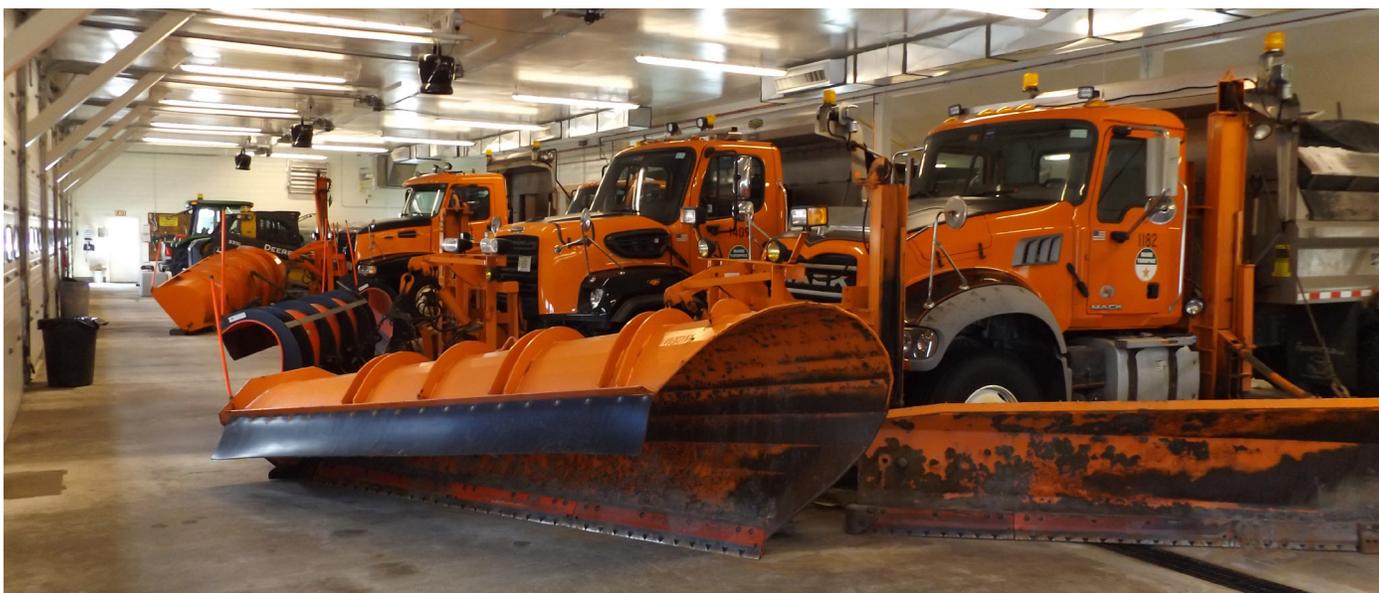
MAINTENANCE GARAGE EXTENSIONS

As a supplement to this Annual Inspection Report, which captures the most pressing needs for improvement, separate Maintenance Reports for the maintenance areas are also created and submitted as part of each annual inspection cycle. We recommend the Authority's maintenance actively address the maintenance items reported to the degree practical.

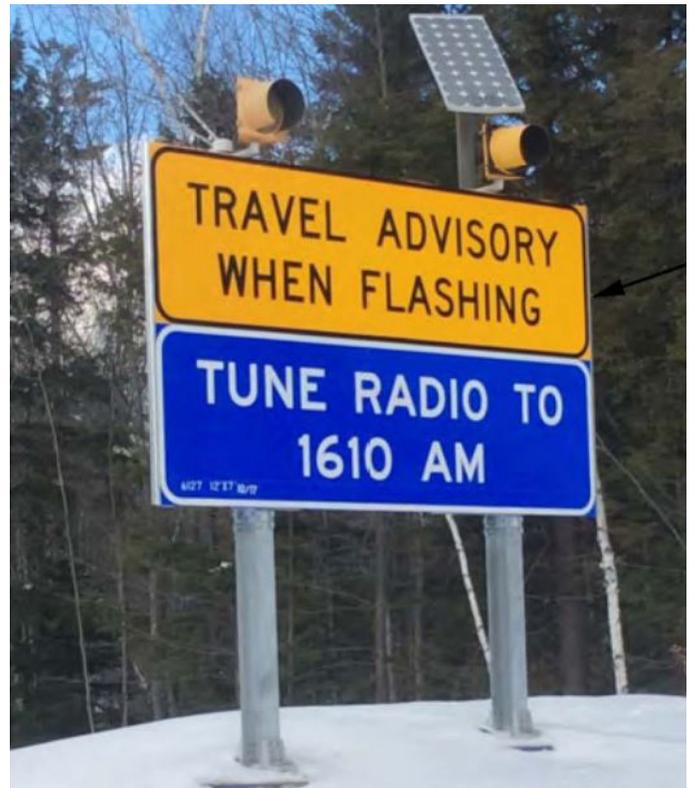
HIGHWAY ADVISORY RADIO SIGN

The Highway Advisory Radio Transmitter Locations are listed in **Table 11** below. Each transmitter location is supplemented by signs advising motorists to tune their radios to 1610 AM to receive real-time Turnpike information.

Prerecorded messages are continually broadcast to provide information about traffic conditions, weather, and construction zones. The Turnpike Communication Center has the ability to control and quickly update messages. The HAR system is a significant resource for providing information to motorists.
