PRESENTED TO THE MAINE TURNPIKE AUTHORITY

OPERATION AND MAINTENANCE ANNUAL REPORT

2015

HNTB

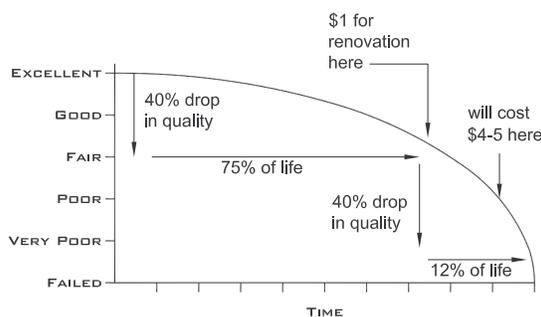
FIGURE 2 - PAVEMENT LIFE CYCLE

FIGURE 2 illustrates the rate of deterioration and relative cost of rehabilitation at various times throughout the Life Cycle of a section of pavement. Evidence that pavement requires rehabilitation includes wheel rutting, excessive cracking, and poor ride quality.

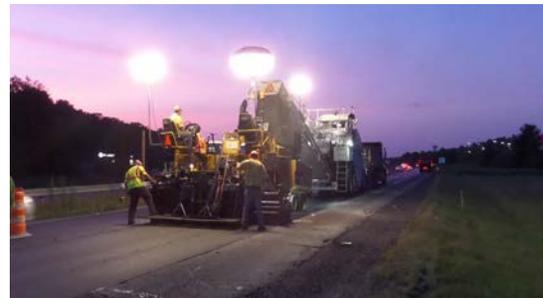
and performance. This practice continued in 2015. Contract 2015.01 rehabilitation work consists of milling and filling the travel lanes northbound and southbound from Mile 51 to Mile 54.5; 3.8 miles eastbound and westbound on the Falmouth Spur, excluding the area either side of the toll plaza; and pavement rehabilitation on the Exit 52 northbound and southbound off-ramps. Contract 2015.02 rehabilitation work consists of milling and resurfacing the travel lanes and the median shoulder from Mile 68.5 to Mile 74.9 in Auburn. Contract 2015.03 rehabilitates the pavement at Exit 46. In all locations, the top 2" of the existing roadway surface is being removed, cracks filled, and the pavement is then replaced with a 1/2" shim and a 1-1/2" lift of surface pavement. These contracts are currently ongoing.

PAVEMENT REHABILITATION, MM 102.6 TO MM 109.1

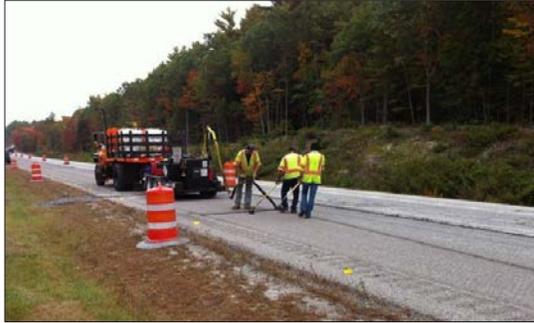
DISPENSED AT OVER 350 DEGREES THE RUBBERIZED ASPHALT SEALANT IS INJECTED DIRECTLY INTO THE PAVEMENT CRACKS

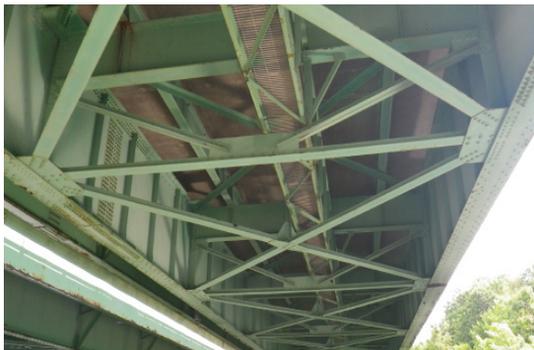
ANDROSCOGGIN RIVER BRIDGE

The Androscoggin River Bridges, each measuring 850 feet long, consist of roadway surfaces supported on stringer and floor beam framing systems. The loads from these roadway framing systems are carried nearly entirely by two primary girders.

Because these structures are carried by only two primary girders, the bridge has insufficient redundancy to prevent a progressive collapse of all, or part of, the

bridge if one of the primary girders were to fail. As a result, these structures are classified as “fracture critical” and are subject to more rigorous inspection requirements as outlined in FHWA’s Bridge Inspection Standards. To achieve compliance with these inspection standards, the Androscoggin River Bridges should have a fracture critical inspection completed at least once every 24 months. The last fracture critical inspection was completed in spring 2015. No significant concerns were identified other than the detachment of the recently constructed wrapping between the tendon sleeve and the anchorage device at several locations. The repair of this condition is warranty work and the Authority is working with the Contractor for its repair. The next fracture critical inspection of this structure should be scheduled for early-2017.

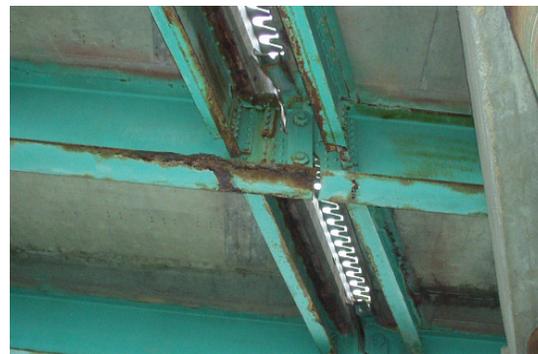
At the York River Bridges, the girder framing system includes pin-and-hanger assemblies. Because routine inspection procedures are insufficient to identify defects in the pins, ultrasonic testing of these elements is necessary. A detailed inspection and ultrasonic testing of the pin-and-hanger systems at the York River Bridges was completed in December 2011. No serious structural deficiencies were noted during that inspection. The next ultrasonic inspection of the pins should be completed in 2016.

PIN-AND-HANGER ASSEMBLY UNDER A FINGER JOINT AT THE YORK RIVER BRIDGE

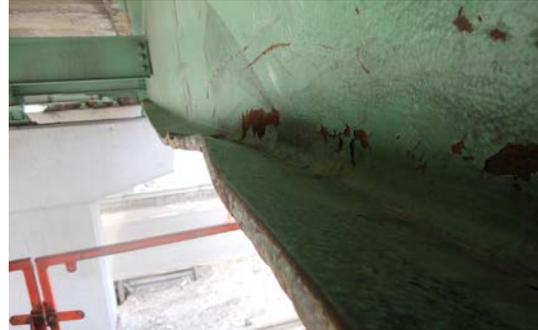
DUTTON HILL ROAD UNDERPASS, MILE 59.9

The Dutton Hill Road Underpass at Mile 59.9 was struck by an overheight vehicle traveling northbound on June 8, 2015 and again on July 11, 2015. HNTB conducted special damage inspections after both of

these occurrences and noted to the Authority that the minor damage did not present a load capacity concern so repairs were not recommended.

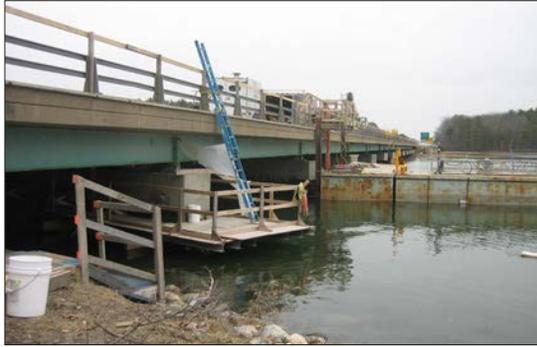
YORK RIVER OVERPASS, MILE 5.2

The project includes new bridge wearing surface, deck repairs, pile jacket repairs, pin and hanger repair, and repairs to the substructure.

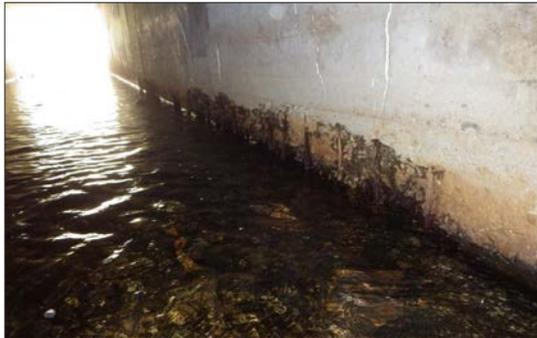
CAPE NEDDICK RIVER BOX CULVERT, MILE 9.6

This double concrete box culvert exhibits areas of advanced concrete deterioration throughout the structure. The work includes chipping and patching areas of deteriorated concrete within the culvert and on its headwalls and wingwalls.

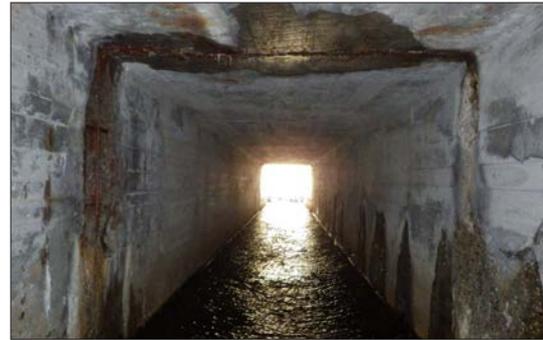
JOSIAS RIVER BOX CULVERT, MILE 11.8

This double concrete box culvert exhibits areas of advanced concrete deterioration throughout the structure. The work includes chipping and patching areas of deteriorated concrete within the culvert and on its headwalls and wingwalls.

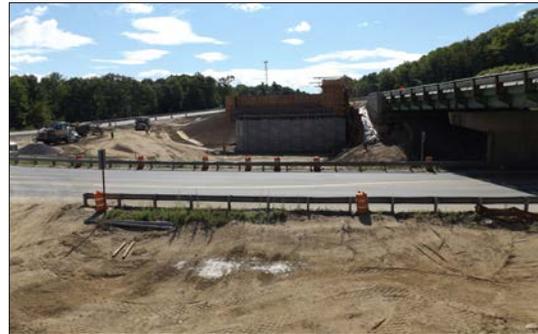
New bridges are under construction as part of the Lewiston Interchange reconstruction project. The bridge will be longer to facilitate

the construction of a single point urban interchange.

NEW LEWISTON BRIDGE UNDER CONSTRUCTION, MILE 80.3

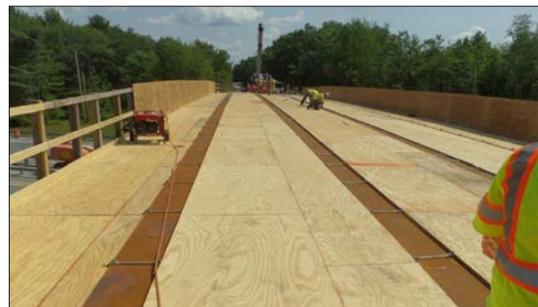
The work includes the removal and replacement of the steel superstructure, concrete deck, wearing surface, and joints. It also includes raising the structure to increase the clearance between the bottom of the bridge to the roadway pavement beneath the bridge to minimize the potential of overheight vehicle collisions.

LUNTS HILL ROAD UNDER CONSTRUCTION, MILE 99.0

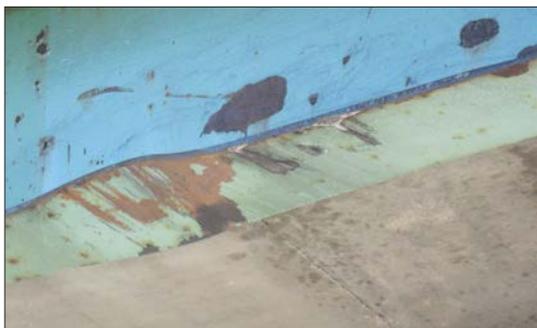
Emergency bridge repairs are periodically required and are usually related to a collision. Minor repairs are completed by Authority Maintenance forces; however, significant repairs warranting heavy equipment or specialty services such as heat straightening are completed through construction contracts. The Hackett Road Underpass at Mile 76.9 was struck by an overheight vehicle traveling south on October 7, 2014 and again on March 20, 2015. HNTB conducted special inspections after both of these occurrences and made recommendations to the Authority for the repair of the impact damage. This repair is now complete.

HACKETT ROAD UNDERPASS IMPACT DAMAGE, MILE 76.9

The Hackett Road Underpass at Mile 76.9 was struck by an overheight vehicle traveling south on October 7, 2014 and again on March 20, 2015. HNTB conducted special damage inspections after both of these occurrences and made recommendations to the Authority for the repair of the impact damage. This repair is now complete.

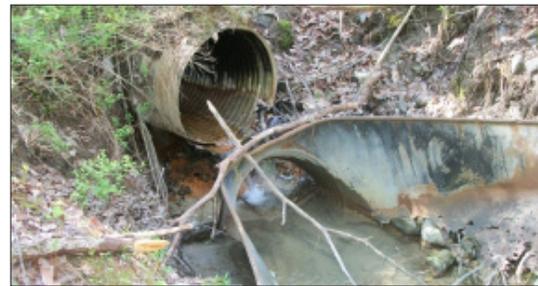
Numerous rivers and streams pass under the turnpike through box culverts and culvert pipes. All box culverts and pipes 60" in diameter or greater are inspected every year (a total of 76 individual culvert ends), and are in satisfactory condition. Culvert pipes 36" to 54" are inspected every five years and were last inspected in 2013. They are in satisfactory condition. These pipes should be inspected again in 2018.

All cross-culverts 30" and smaller are scheduled for inspection between 2013 and 2018. In 2013, the inspection of culverts 30" and smaller from Mile 90 to 109 was completed. This program continued in 2014 with the inspection of culverts 30" and smaller between Mile 50 and 60; and Mile 68 and 75, and on the Falmouth Spur. In 2015, the inspection of all culverts 30" and smaller between Mile 60 and 68 and Mile 75 and 90 was completed. These pipes were found to be in poor to good condition. Many of the cross-culverts are reinforced concrete under the core roadway but change to metal under the side slopes. While the concrete portion of the culverts are generally in fair to good condition, many of the metal pipe ends are in poor condition. Common issues observed are rusted flow lines, disconnected joints, and disconnected metal flared end sections.

These conditions lead to erosion issues on the side slope which may eventually impact the roadway.

drainage, slope repairs and maintenance are completed by the MTA while larger repairs are completed by Contractors. Catch basin repair, pipe repair, winter sand removal, and slope repairs are completed as part of the pavement rehabilitation projects, while isolated areas requiring significant repair are typically bid as a Contract and completed separately. We recommend the continuation of this practice.

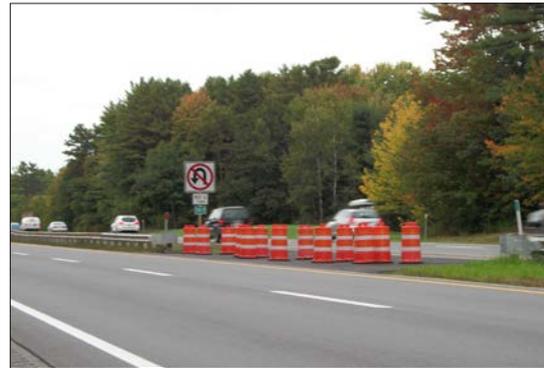
- Installation of thrie beam guardrail at select locations;
- Closing median openings that are not critical for authorized vehicles;
- Constructing new median openings at areas with adequate sight distance;
- Replacing non-crash attenuating guardrail terminal end sections with impact attenuating units;
- Adjusting guardrail heights;
- Improving strength of guardrail at locations where the guardrail was in close proximity to bridge piers;
- Adding additional guardrail; and,
- Constructing new terminal end sections.

This work continued in 2015 with upgrades to the guardrail on the Falmouth Spur; Mile 51 to Mile 54.5; and Mile 68.5 to Mile 74.9 as part of pavement rehabilitation contracts.

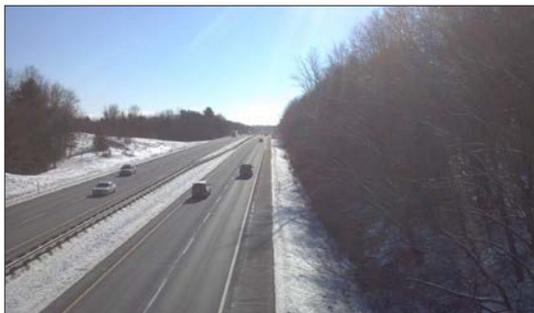
Mile 53.4, Looking South (Before)

As part of a 2015 pavement rehabilitation project, an 1,800' long section of the southbound roadway side slope is under reconstruction in Falmouth to improve safety. In this 1,800 feet, a section of guardrail is being removed and slopes flattened to accommodate a wider roadside recovery area for errant vehicles.

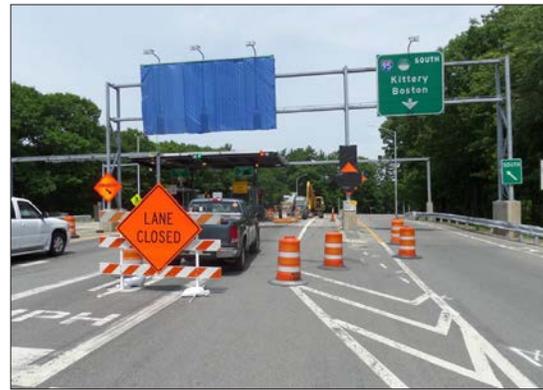
EXIT 19 TOLL PLAZA

The 19 toll plazas comprised of tollbooths, canopies, utility buildings and other structures are in various stages of repairs and upgrades as part of the system-wide upgrade to the Infinity Toll System discussed in the previous section. The tollbooths and canopies are rated in fair to good condition while other components, such as concrete slabs, bumpers and tunnels, are rated in poor to fair condition.

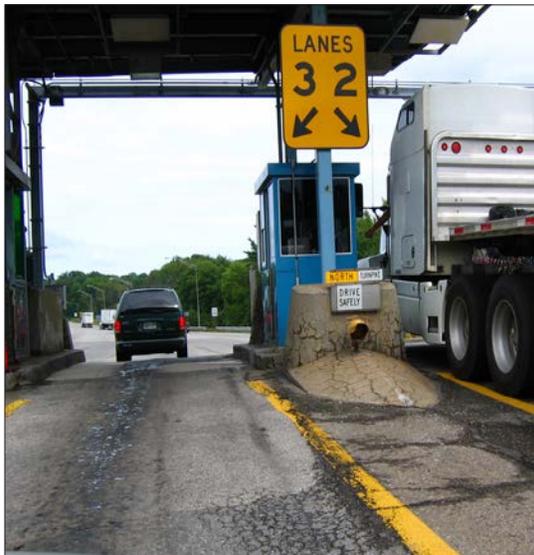
The existing York Toll Plaza was constructed in 1969 and is challenged by both operational and safety issues and the existing toll system has reached the end of its useful life. The plaza is rated in fair to poor condition. Considering the condition of the plaza, decisions relating to the replacement of the toll system should consider the practicality of installing the toll system in the deficient infrastructure, or whether the infrastructure should be upgraded at the existing location, or an alternate location selected for a new plaza.

EXISTING YORK TOLL PLAZA - CONSTRUCTED IN 1969
