PRESENTED TO THE MAINE TURNPIKE AUTHORITY

OPERATION AND MAINTENANCE ANNUAL REPORT

2017

HNTB

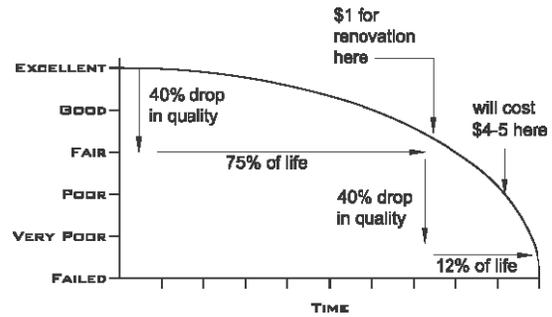
FIGURE 2 - PAVEMENT LIFE CYCLE

FIGURE 2 illustrates the rate of deterioration and relative cost of rehabilitation at various times throughout the Life Cycle of a section of pavement. Evidence that pavement requires rehabilitation includes wheel rutting, excessive cracking, and poor ride quality.

Studies indicate that pavement maintained in good condition costs substantially less to preserve than pavement that is allowed to deteriorate to poor condition. Based on this concept, the Authority’s resurfacing program consists of rehabilitating one or more sections of roadway, totaling approximately ten centerline miles each year, in order to minimize the cost of future repairs.

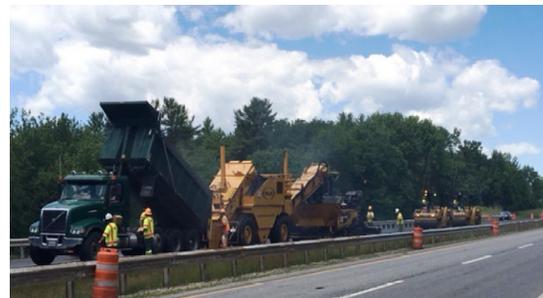
PAVEMENT REHABILITATION

Starting in 2014, pavement rehabilitation contracts specified polymer modified asphalt to alter several characteristics of the asphalt, each of which is intended to improve pavement durability, weatherability and performance. This practice has continued into 2017. The areas using this additive will be evaluated to determine if its use is providing adequate benefit. Due to poor condition of the pavement between Mile 80.7 and Mile 88.6, pavement rehabilitation was performed under Contract 2017.01. The rehabilitation work from Mile 86.0 to Mile 88.6 consists of milling and filling the 12-foot wide lanes and the median shoulder. Additional crack repairs were performed before paving back in the milled area. The rehabilitation work from Mile 80.7 to Mile 86.0 included crack repair, shim and full width overlay. Pavement rehabilitation between Mile 64.4 and Mile 68.5 was also performed under Contract 2017.02. This rehabilitation included shimming and overlaying the two 12-foot wide lanes and shoulders. These contracts are currently ongoing.

Due to generally fair conditions of the pavement between Mile 75 and Mile 80 and between Mile 98 and Mile 103, and to maintain pavement quality and roadway safety, HNTB recommends the rehabilitation of the northbound and southbound roadway in that area. The rehabilitation should consider removing 2” of existing travel lane pavement, crack sealing and/or repair, shimming, and paving a new surface. These projects should also include repairs to the drainage system such as catch basin repair and repairing pipe outlets.

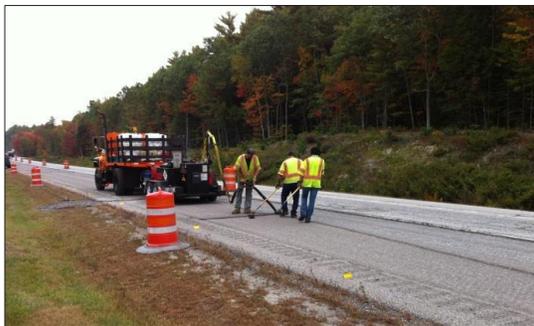
DISPENSED AT OVER 350 DEGREES THE RUBBERIZED ASPHALT SEALANT IS INJECTED DIRECTLY INTO THE PAVEMENT CRACKS

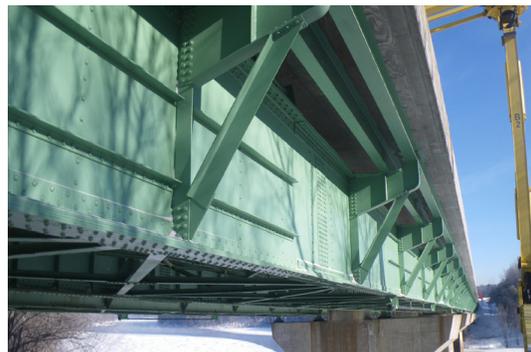
ANDROSCOGGIN RIVER BRIDGE

The Androscoggin River Bridges, each measuring 850 feet long, consist of roadway surfaces supported on stringer and floor beam framing systems. The loads from these roadway framing systems are carried almost entirely by two primary girders.

Because these structures are carried by only two primary girders, the bridge has insufficient redundancy to prevent a progressive collapse of all, or part of, the bridge if one of the primary girders were to fail. As a result, these structures are classified as “fracture critical” and are subject to more rigorous inspection requirements as outlined in FHWA’s Bridge Inspection Standards. To achieve compliance with these inspection standards, the Androscoggin River Bridges should have a fracture critical inspection completed at least once every 24 months. The

last fracture critical inspection was completed in spring 2017. No significant concerns were identified other than necessary substructure and bearing repairs which are being addressed in a 2018 repair contract. The next fracture critical inspection of this structure should be scheduled for 2019.

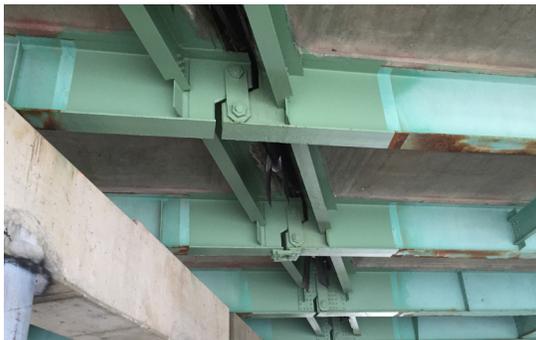
PIN-AND-LINK ASSEMBLY AT THE YORK RIVER BRIDGE

At the York River Bridges, the girder framing system includes pin-and-link assemblies. Because routine inspection procedures are insufficient to identify defects in the pins, ultrasonic testing of these elements is necessary. A detailed inspection and ultrasonic testing of the pin-and-link systems at the York River Bridges was completed in December 2011. No serious structural deficiencies were noted during the inspection. The next detailed inspection of the pin-and-link assemblies was scheduled for 2016, however, a 2015 rehabilitation contract involved disassembling, reassembling, and painting the pin-and-links. This was justified as an acceptable detailed inspection procedure and ultrasonic testing was not performed. The next detailed inspection including ultrasonic testing should be scheduled for summer 2020.

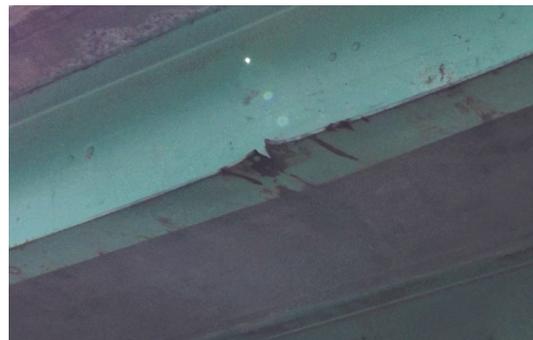
HACKETT ROAD UNDERPASS, MILE 76.9

The Hackett Road Underpass at Mile 76.9 was struck by an overheight vehicle on an unknown date following the 2016 annual

bridge inspection completed on June 14, 2016. On April 19, 2017, HNTB conducted a special inspection and made a recommendation to the Authority for the replacement of the damaged north fascia girder and repair the gouges on bottom flange of the south fascia girder. Part of the recommendation included temporarily restricting traffic with drums to avoid overstressing the damaged girder.

The Hackett Road Underpass at Mile 76.9 was struck by an overheight vehicle on an unknown date following the 2016 annual bridge inspection completed on June 14, 2016. On April 19, 2017, HNTB conducted a special inspection and made a recommendation to the Authority for the replacement of the damaged north fascia girder and the gouges on bottom flange of the south fascia girder be removed by grinding. The repair work is under contract.

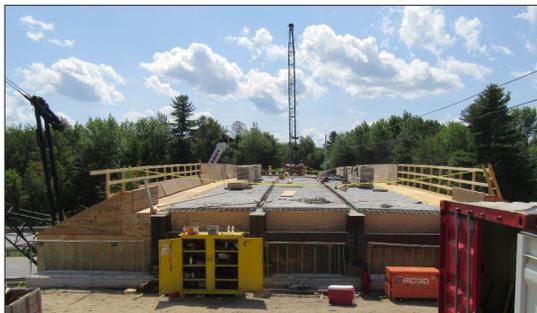
MAXWELL ROAD UNDERPASS, MILE 90.0

The work includes demolition of the existing one lane bridge and the construction of a new two lane bridge with increased vertical clearance.

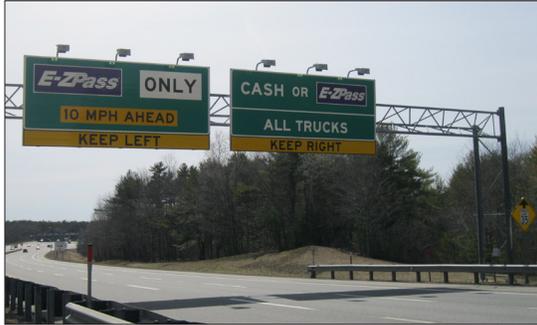
OVERHEAD SIGN BRIDGE MAINLINE SB, MILE 7.8

bridge-mounted signs. These structures carry regulatory, route marker, warning, and specialty signage. Routine or ground inspection of the Authority's sign structures is conducted yearly as part of the routine bridge inspection and no significant issues have been observed.

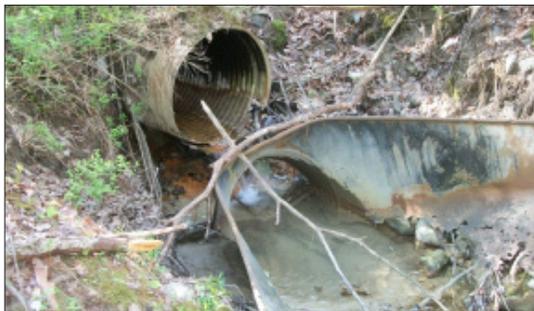
These pipes were found to be in good to poor condition. Many of the cross-culverts are reinforced concrete under the core roadway but change to metal under the side slopes. While the concrete portion of the culverts are generally in fair to good condition, many of the metal pipe ends are in poor condition. Common issues observed in the metal pipe ends are rusted flow lines, disconnected joints, and disconnected metal flared end sections. Common issues observed in the reinforced concrete pipe ends are inlets and outlets that are either partially or completely obstructed by heavy vegetation or debris and buried inlets and outlets. These conditions lead to erosion issues on the side slope which may eventually impact the roadway.

Periodically the Authority issues contracts to repair drainage issues that the Authority's Maintenance forces cannot repair due to their location or the type of equipment required to cost effectively complete the repair.

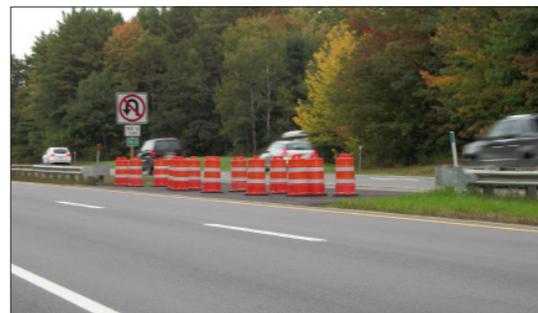
The FHWA has a September 29, 1994 policy, and subsequent memorandums in 2005, 2010, 2014, and 2016, that all roadside hardware (guardrail) installed on the National Highway System comply with the crash testing and evaluation criteria contained in the Manual for Assessing Safety Hardware (MASH) or its predecessor the National Cooperative Highway Research Program (NCHRP Report 350 - published in 1993). FHWA further suggested that the non-crashworthy hardware be removed or replaced with crashworthy roadside hardware at the earliest possible opportunity in concert with the maintenance of the roadway.

A program to upgrade Maine Turnpike guardrail by construction contract was initiated in 1996. This program includes the following:

- Installation of thrie beam guardrail at select locations;
- Closing median openings that are not critical for authorized vehicles;
- Constructing new median openings at areas with adequate sight distance;
- Replacing non-crash attenuating guardrail terminal end sections with impact attenuating units;
- Adjusting guardrail heights;
- Improving strength of guardrail at locations where the guardrail was in close proximity to bridge piers;
- Adding guardrail; and,
- Constructing new terminal end sections.

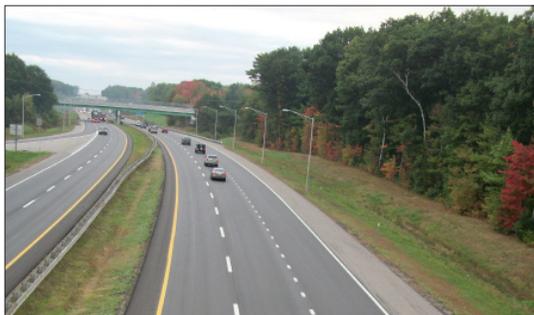
The Authority's Maintenance forces re-stripe the turnpike once a year to maintain roadway markings in good condition.

The Authority is also utilizing reflectorized pavement marking tape installed in grooves at interchange ramps and to supplement the white skip lines on the mainline. The tape improves visibility of the pavement markings in wet conditions and at night.

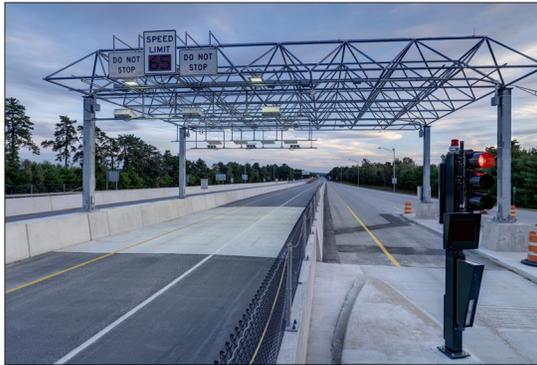
NEW GLOUCESTER TOLL PLAZA ORT, MILE 67.0

The Infinity Toll System has been installed at both the New Gloucester and West Gardiner mainline tolls and its implementation is complete at Exits 19, 25, 42, 46, 47, 48 and nearing completion at Exits 32, 36 and 53.

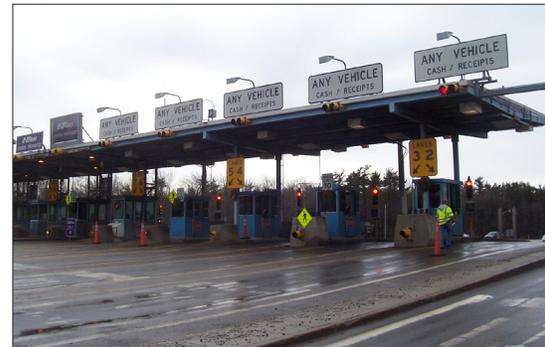
EXISTING YORK TOLL PLAZA - CONSTRUCTED IN 1969

The existing York Toll Plaza was constructed in 1969 and is challenged by both operational and safety issues and the existing toll system has reached the end of its useful life. The plaza is rated in fair to poor condition.

Considering the condition of the York Toll Plaza, decisions relating to the replacement of the toll system should consider the practicality
