## 2025 OPERATION AND MAINTENANCE ANNUAL REPORT

PRESENTED BY: HNTB CORPORATION

PRESENTED TO: MAINE TURNPIKE AUTHORITY

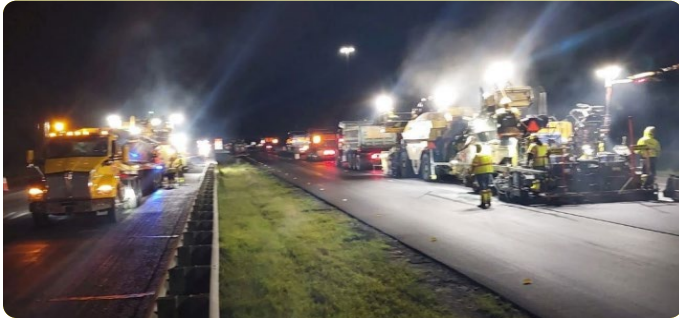
*Photo 2: Pavement Rehabilitation*

For calendar year 2025, several mainline pavement rehabilitation and drainage improvement projects are underway, including sections between Mile 13.4 and Mile 20; Mile 42 and Mile 49.3 northbound (NB); and Mile 51.2 and Mile 54.5.

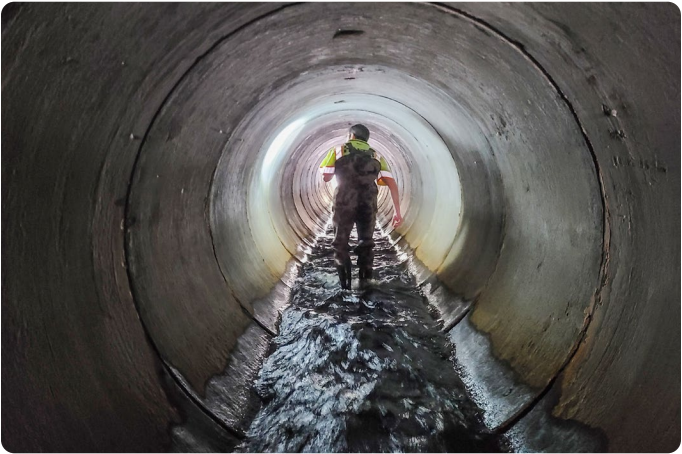
Photo 3: Large Diameter Culvert Inspection

All box culverts and pipes with spans or diameters between 60 inches and ten feet, totaling 34 crossings, are inspected annually. When conditions allow, HNTB conducts internal inspections by walking through the culverts. If safe access is not possible, visual inspections are performed from each end. Structures that cannot be adequately assessed visually, due to submersion or other obstructions, are flagged for special inspection using robotic camera technology. The last full robotic inspection, completed in 2018, included 18 culverts 60 inches or greater in diameter and found them to be in generally satisfactory condition.

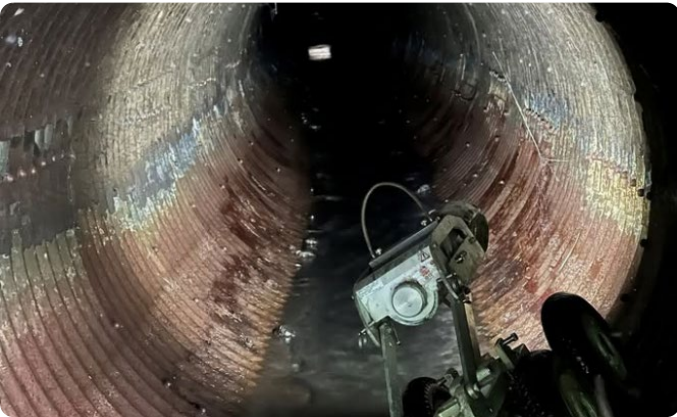
Photo 4: Vortex Small Diameter Culvert Inspection (Not an MTA Culvert)

As part of broader efforts to enhance inspection oversight and reduce the risk of culvert failure and costly slope repairs, culverts rated as poor in previous cycles received out-of-cycle follow-up inspections in 2024. Additional detailed inspections are scheduled for fall 2025, targeting culverts identified in the 2025 annual inspection and past assessments. Priority is given to structures in poor condition, under high fill, or with limited accessibility—primarily between Mile 0.3 and Mile 25. These inspections, to be conducted by Vortex Companies, will inform long-term planning and maintenance prioritization.

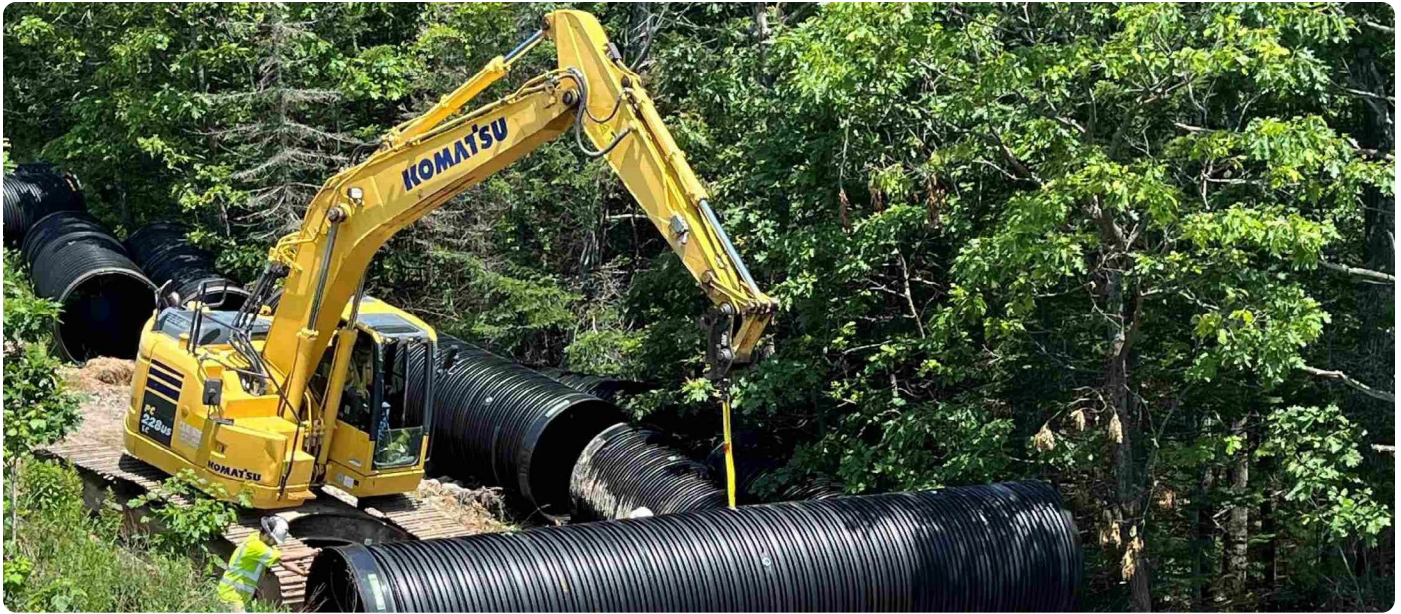
*Photo 5: Culvert Slip Lining*

Many smaller cross-culverts have reinforced concrete pipe (RCP) sections directly under the core roadway but switch to corrugated metal or high-density polyethylene under the side slopes. While the concrete sections are generally in fair to good condition, the metal pipe ends are often in poor condition, showing issues such as rusted flow lines, disconnected joints, and detached metal flared end sections. The reinforced concrete and polyethylene pipe ends frequently have inlets and outlets obstructed by heavy vegetation, debris, or outwash from areas of slope erosion. These conditions can cause erosion on the side slopes, potentially impacting the roadway over time.

The MTA routinely replaces the corrugated metal culvert ends with reinforced concrete or high-density polyethylene as resources and funds allow. More than 95 smaller culvert ends were replaced by maintenance between 2021 and August 2024. An additional 25 culvert ends were replaced in the Litchfield and West Gardiner area in 2025, and an additional 25 culvert ends are planned for replacement in 2026. The MTA's multi-year program developed to replace all aging metal culvert ends will be substantially complete at the end of 2026.

We recommend the continued repair of culvert end locations rated in poor condition, as detailed in the Annual Inspection Report and identified through notable finding recommendations, with a goal of completing this effort by the end of the 2026 construction season. Once complete, these repairs will reduce the potential for more significant and costly improvements in the future.

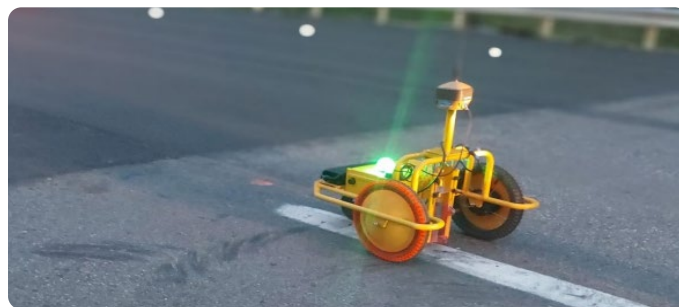
*Photo 9: Robotic Striping Layout (Operated by Pike Industries)*

Double yellow lines in two-way traffic areas within interchanges and newly paved areas are typically painted twice a year. This frequency has been adequate to maintain roadway striping.

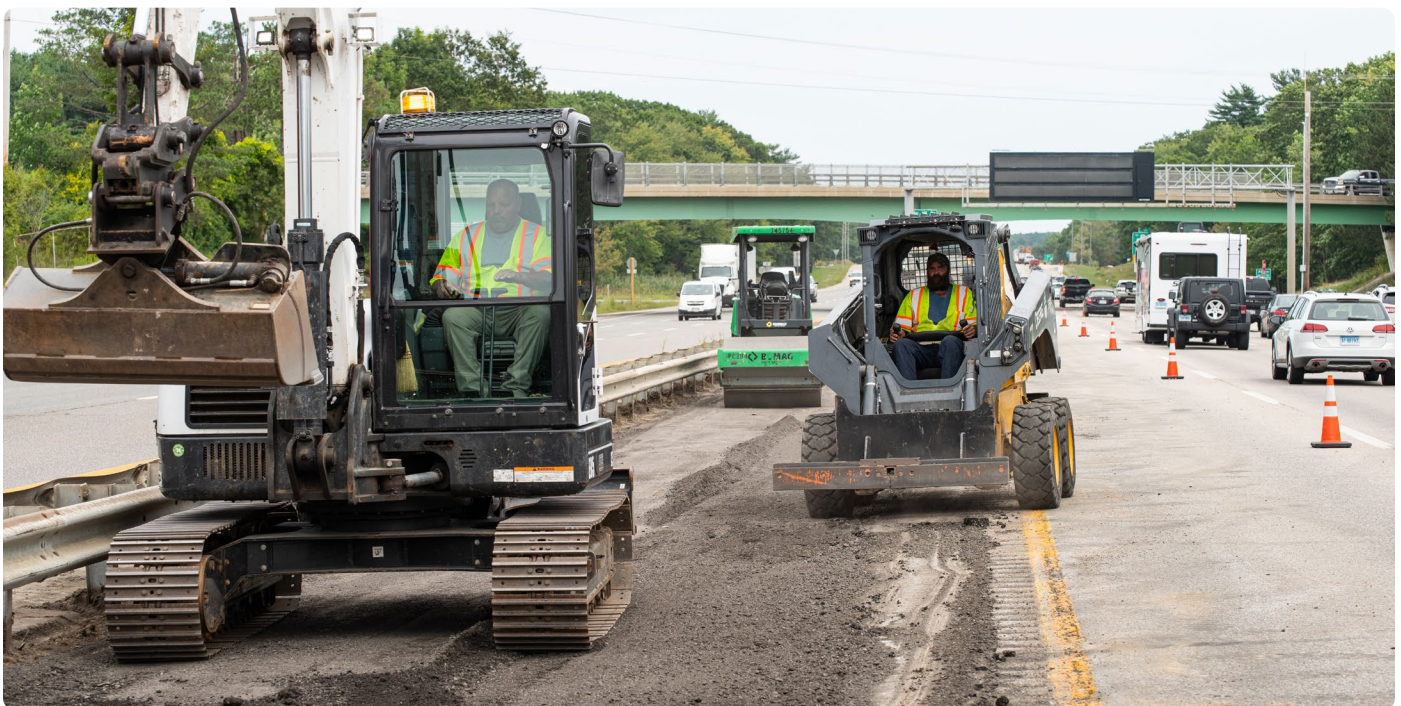
Photo 10: Median Grading Operations

To date, median safety and modernization improvements, including replacing vegetative cover with pavement and installing concrete barriers, have been completed between Mile 0.3 and Mile 1.3; Mile 7.0 and Mile 7.6; Mile 8.1 and Mile 9.6; and Mile 43 and Mile 49.

Most roadway side slopes are stable and well-vegetated, but some areas have minimal vegetation, leading to erosion. The Annual Inspection Report details locations needing minor corrective action, including winter sand buildup, localized sloughing (especially around structures), and erosion from roadway runoff. Corrective measures are also needed where gravel shoulders are too low compared to paved shoulders and for minor erosion that could worsen over time. The MTA's maintenance forces should continue to handle these repairs as required, with larger-scale repairs integrated into adjacent paving contracts or bid as separate projects.

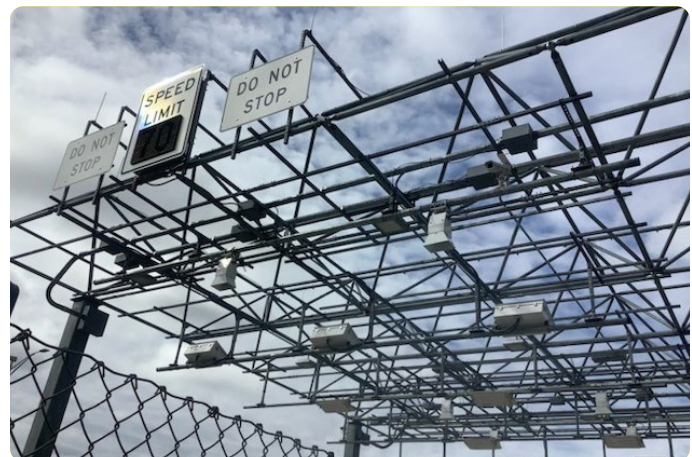
*Photo 12: Toll Equipment (Spaceframe Infrastructure)*

A May 2013 toll system assessment report outlined that the legacy cash toll collection system installed in 2004 provided acceptable levels of performance, reliability, and system uptime based on the originally intended functionality. However, the system was reaching the end of its anticipated life. In response, the MTA implemented a program to convert its legacy cash toll collection system at all toll plazas to a new toll collection system called the "Infinity System." The Infinity System has specific infrastructure requirements, such as vehicle detection loops installed in a concrete roadway slab with non-

metal reinforcement. The slabs are required to meet specific dimensional requirements to accommodate the way the loops are embedded in the concrete slab to sense vehicles and interact with other toll collection equipment.

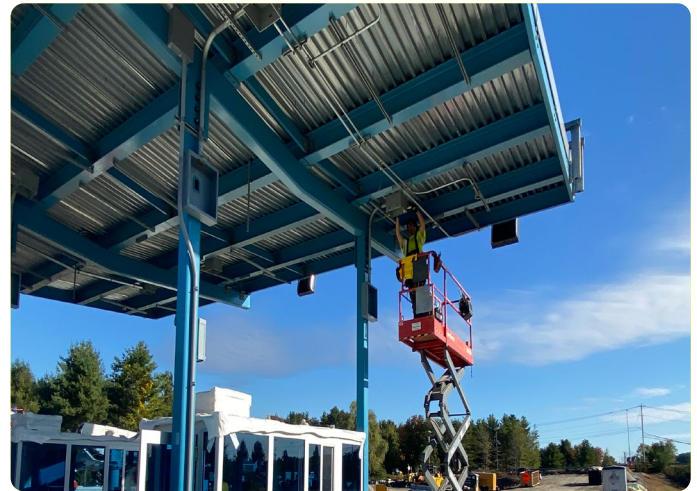
*Photo 13: Saco Toll Canopy Construction*

project includes construction of NB and SB ramps, a SB toll plaza on the west side of the Turnpike, and a NB toll plaza on the east side—both with signalized intersections at Route 112.

The work also includes widening of the Turnpike for a SB collector-distributor road, improvements to Route 112, and construction of new access roads. Final elements, such as tolling equipment, administration buildings, canopies, and supporting infrastructure, are being completed, with full project completion expected soon.

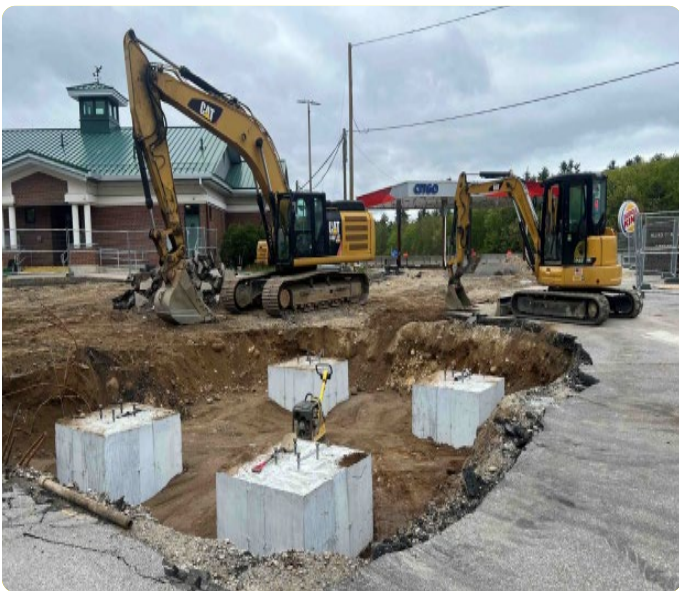
Photo 14: Cumberland Service Plaza Construction

Replacement of the fuel system at the Gray service plaza was completed in spring 2021. The Cumberland fuel system received maintenance repairs and was satisfactorily tested in spring 2020. Replacement of the Cumberland fuel system is underway and is scheduled for completion by fall 2025.

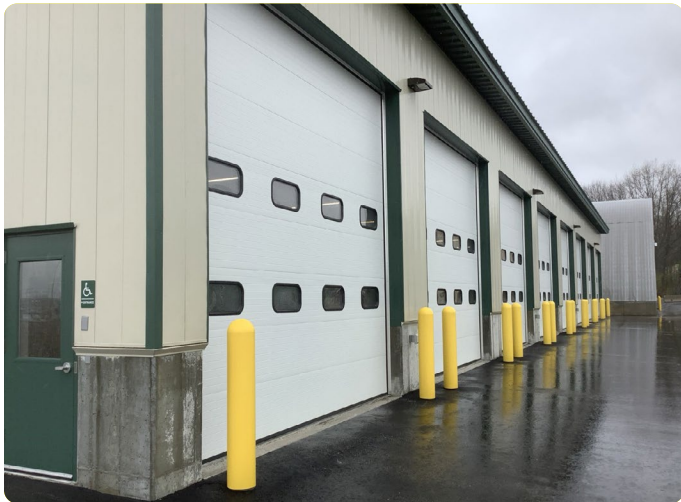
*Photo 16: Crosby Maintenance Eight-Bay Garage*

In 2024, an eight-bay garage was added at the Crosby Maintenance Facility to house Turnpike equipment and plow trucks needed for winter maintenance on newly widened lanes in the Portland area.

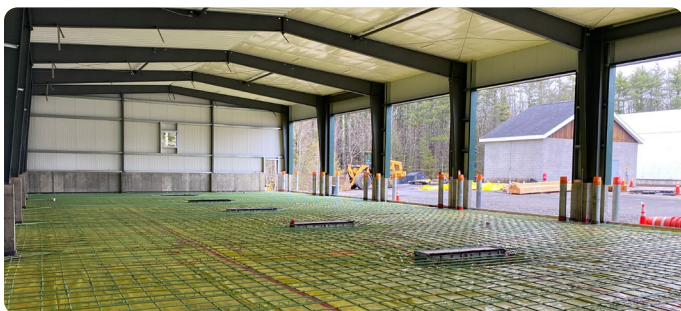
*Photo 17: York Maintenance Eight-Bay Garage Construction*

Construction of a six-bay storage garage at York Maintenance (Chases Pond Road) began in 2024 and is expected to finish in fall 2025. An eight-bay garage at the Auburn Maintenance Yard was advertised in 2025, with completion set for 2026, replacing the building destroyed by fire in February 2025.

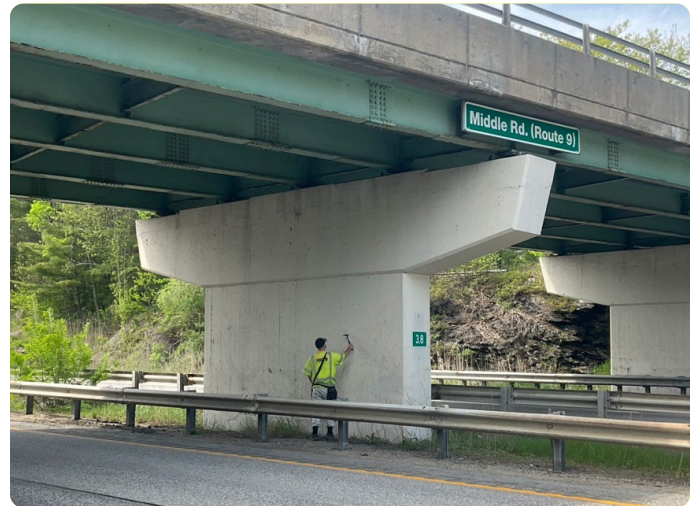
*Photo 19: Median Pier Inspection*

Qualified inspectors conduct inspections of MTA-owned bridges and minor spans in accordance with the NBIS. Several types of inspections occur based on structure type, information needed, and federal regulations. These different inspection types are discussed in more depth in the following sections. Once these inspections are complete, the condition ratings for each structure are compiled and transmitted to MaineDOT for inclusion in the NBI.

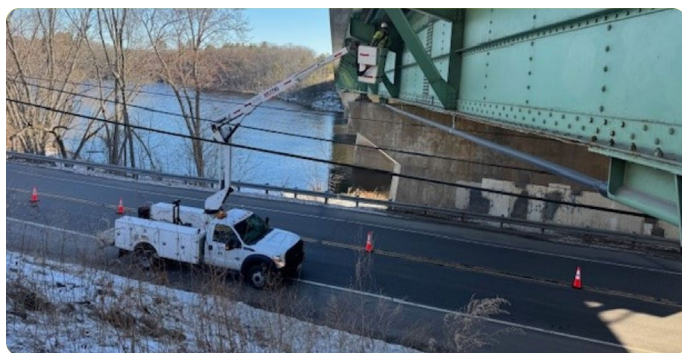
*Photo 20: Androscoggin River Bridge Inspection*

Detailed inspections are completed on bridges with special features that warrant increased attention and inspection effort. Two sets of Turnpike structures, the Androscoggin River Bridges and the York River Bridges, require detailed inspections.

The Androscoggin River Bridges, each measuring 850 feet long, consist of roadway surfaces supported on stringer and floor beam framing systems. The loads from these roadway framing systems are carried almost entirely by two primary girders. Because these structures are carried by only

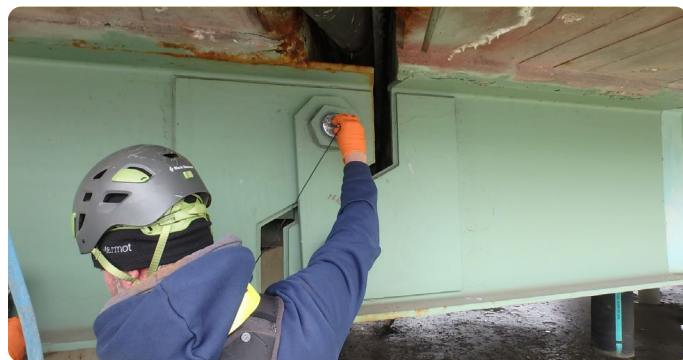
*Photo 21: York River Bridge Pin-and-Link Inspection*

At the York River Bridges, the girder framing system includes pin-and-link assemblies. Because routine inspection procedures are insufficient to identify defects in the pins, ultrasonic testing of these elements is necessary. A five-year inspection frequency for ultrasonic testing is suggested. This frequency is based on engineering judgment since the FHWA does not have a required frequency for these components.

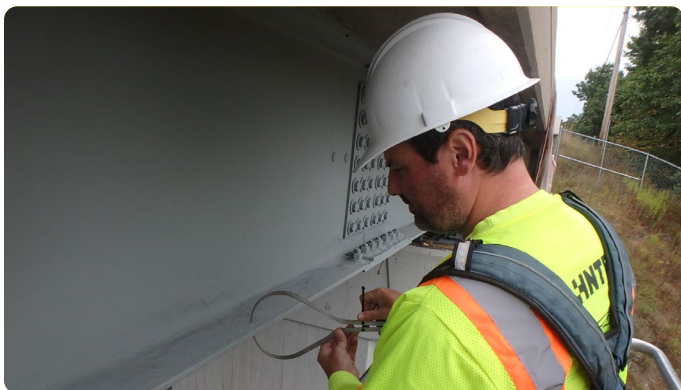
Photo 22: Bennett Road Bridge Section Loss Measurements

Additionally, in August 2025, during the ongoing bridge painting contract, the Resident Engineer identified moderate to heavy section loss at the Bennett Road Bridge Underpass (Mile 68.6). This deterioration was discovered during required girder surface preparation and cleaning activities. The section loss was localized to the south exterior girder over the NB Turnpike lanes, primarily in areas exposed to salt spray and chloride-laden moisture. HNTB conducted a site visit to document the extent of the damage and recommended a load rating update to assess the structural implications of the corrosion. The load rating update is in progress.

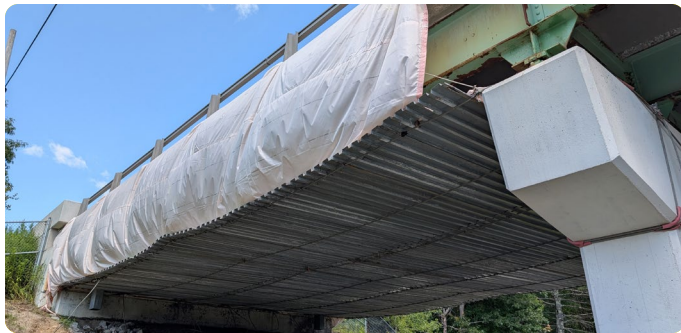
*Photo 24: Bridge Painting Containment System*

The following bridges were contracted for painting in 2024, with the completion of work scheduled for 2025:

- Shaker Road Underpass (Mile 64.3)
- Weymouth Road Underpass (Mile 66.2)
- Bennett Road Underpass (Mile 68.6)

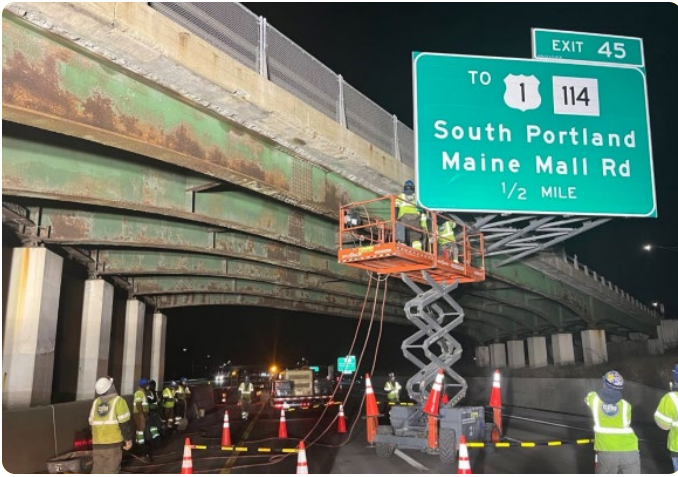
*Photo 25: I-295 SB Underpass Haunch Removal*

On many Turnpike bridges built before the mid-2000s, the deck steps downward outside the edges of each bridge girder, a detail that bridge owners commonly used throughout the region. Agencies have since determined that these unreinforced concrete deck sections, referred to as "widened concrete haunches," are prone to premature cracking and deterioration. In some instances, portions of the concrete haunch have fallen onto the roadway below. MTA-owned bridges with this detail have been identified and prioritized for periodic inspection by maintenance crews and for removal of the widened haunches by contract as resources allow. Contract 2025.05 initially included the removal of haunches at six bridge locations. As the contractor had additional availability during the project, extra bridge sites were added and completed as part of the contract through approved additional work. Future removal contracts of similar size are anticipated for advertisement in 2026, 2027, and 2028 at which time all MTA-owned bridges identified as high priority will have been addressed. Maintenance and inspection crews will continue to monitor the "widened concrete haunches" left in place.

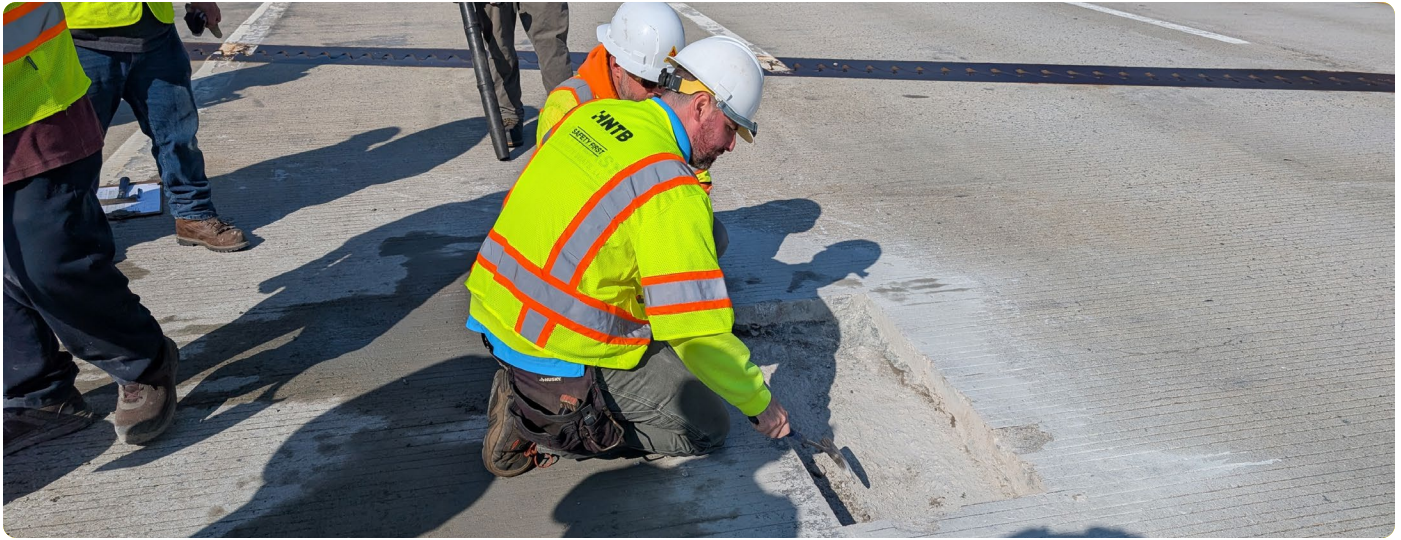
Photo 26: York River Bridges Wearing Surface Repair

For instance, in May 2025, a special inspection was conducted to address potholing of the concrete wearing surface on the NB York River Bridge. MTA maintenance crews performed a concrete patch repair on a deteriorated section of the bridge deck, supported by a representative from Sika who demonstrated installation procedures for a concrete repair product under consideration for future use. HNTB was present to delineate the required repair limits, observe the repair process, and complete an inspection of the wearing surface while traffic control was in place. The soundings taken during this inspection will serve as a historical record to monitor surface degradation over time and support future capital planning efforts.
