## 2023 OPERATION AND MAINTENANCE ANNUAL REPORT

PRESENTED BY: HNTB CORPORATION  
PRESENTED TO: MAINE TURNPIKE AUTHORITY

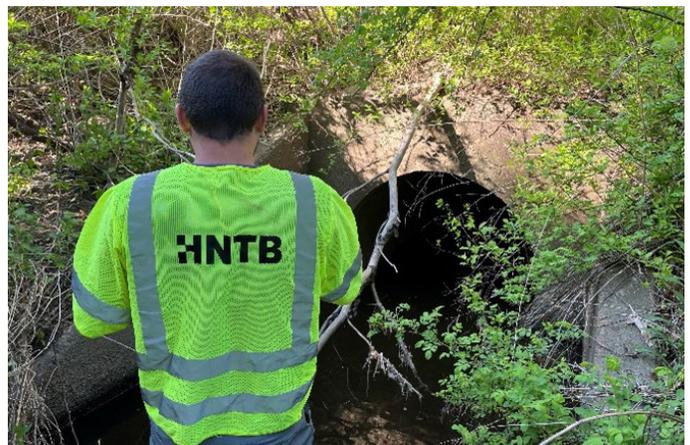
Annual Inspection Culvert Condition Assessment

The results of the 2023 annual inspection, and the last special inspection completed in 2018, determined culverts 60" or greater in diameter were in generally satisfactory condition. In some locations culvert ends are deteriorating and separating from adjacent sections.

The 2023 annual inspection found culverts ranging from 36" to 54" in diameter were in fair to satisfactory condition. Culverts measuring 30-inch in diameter or less ranged from good to poor condition.

Many smaller cross-culverts are reinforced concrete directly under the core roadway but change to corrugated metal or high-density polyethylene under the side slopes. While the concrete portion of the culverts are in generally fair to good condition, the remaining metal pipe ends are in poor condition. Common issues observed at the metal pipe ends are rusted flow

lines, disconnected joints, and disconnected metal flared end sections. Common issues observed in the reinforced concrete and polyethylene pipe ends are inlets and outlets that are either partially or completely obstructed by heavy vegetation or debris and buried inlets and outlets. These conditions lead to erosion issues on the side slope which may eventually impact the roadway.

We recommend the continued repair of culvert end locations rated in poor condition, as detailed in the Annual Inspection Report, with a goal of completing this effort by 2026. Once complete, these repairs will reduce the potential for more significant and costly

improvements in the future, such as slope failures and sinkholes. Eight circular culvert end locations remain in poor condition. The number of poor condition culverts has improved significantly since 2021 with the total number of poor condition culverts reduced by more than two thirds.

Based on inspection findings from 2022 and 2023, we recommend design development of a culvert rehabilitation project by slip lining of the 240 foot, 78" Reinforced Concrete Pipe at mile mark 40.3 which passes the Dunstan River under the turnpike. The existing culvert has deflections up to 1" and concrete delamination near the midpoint and has approximately 30' of fill covering it with challenging site access.

Culvert locations that can reasonably be repaired by the Authority's Maintenance forces should be prioritized and addressed as resources become available. These repairs typically include replacing deteriorated metal pipe ends with high density polyethylene or reinforced concrete pipe, together with associated slope and drainage channel stabilization work.

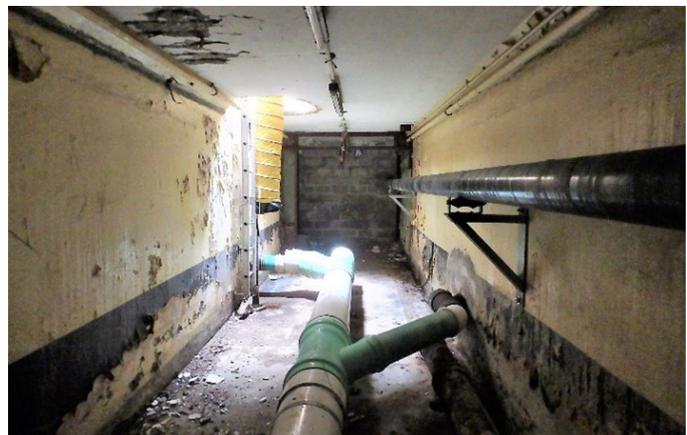
Kennebunk Service Plaza Utility tunnel

An approximately 8' wide by 8' tall reinforced concrete utility tunnel passes beneath the Turnpike Mainline between the Kennebunk NB and SB service plazas at Mile Marker 25.52. The tunnel carries both sewer and natural gas lines beneath the highway. A structural inspection and condition assessment of the tunnel is completed on a 5-year cycle. The most recent inspection occurred as part of the 2023 annual inspection. That inspection determined that the tunnel is in fair condition. Unutil, owner of the gas line, reviewed the gas line during the 2023 inspection and did not report any findings of concern. The next inspection of the facility is scheduled for 2028.

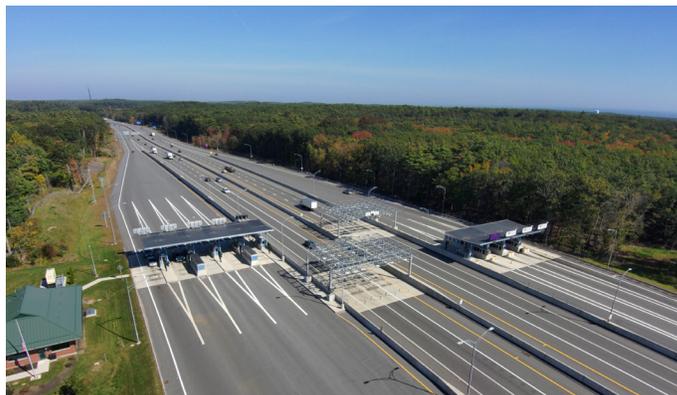
The York Toll Plaza is an Open Road Toll (ORT) Plaza at Mile 8.8, approximately 1-mile north of the original plaza and turnpike Exit 7. The facility features three ORT lanes in each direction as well as five southbound and four northbound cash lanes. This plaza is in new condition.

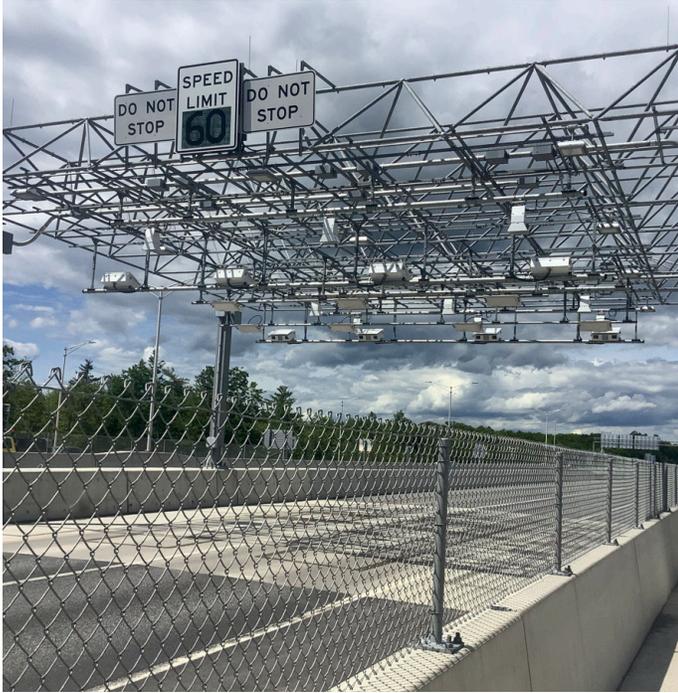
West Gardiner Barrier Toll Plaza ORT Lane

Construction of the new West Gardiner I-295 Mainline Toll Plaza, and removal of the existing plaza, was completed in November 2021. The new facility consists of two ORT lanes and three cash lanes in each direction and operates using the new Infinity Toll System. This plaza is in new condition.

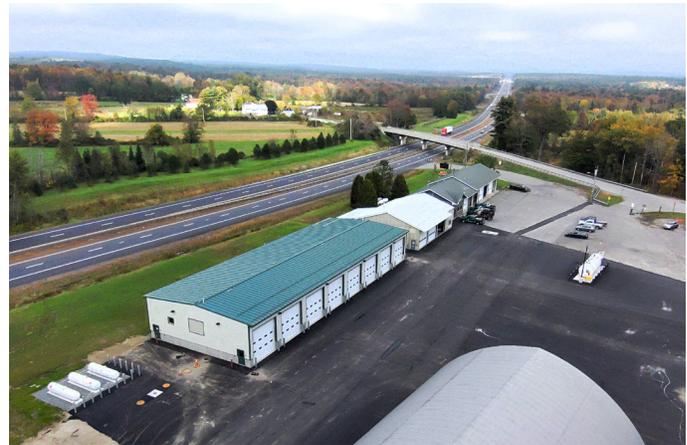
Litchfield Maintenance Reconstructed 8-Bay Garage

The 8-bay garage at the Litchfield Maintenance Yard was destroyed by fire on the evening of December 2, 2021. Following the fire, the design for a replacement garage was completed on a heavily accelerated schedule and a contract for the construction of a new 8-bay garage was awarded in March 2022. Construction of the new garage is underway and is expected to be complete in Fall of 2023.

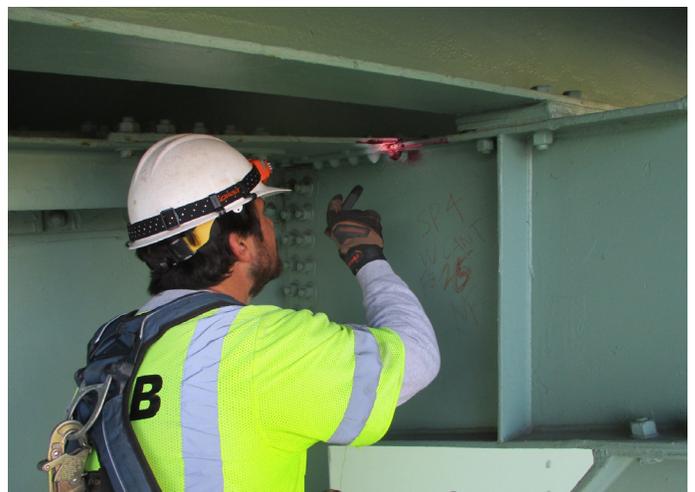
Hands-On Bridge Inspection

ter depths are typically too deep to allow for the use of routine inspection methods. No serious structural deficiencies were noted on the bridges during the 2021 underwater inspection. The overall condition of the visible portions of the underwater substructures ranged from fair to good condition. Most deficiencies observed were attributed to freeze-thaw deterioration and abrasion from ice and debris. One box culvert, Northern Hart Brook at Mile 79.9, was identified as being in poor condition.

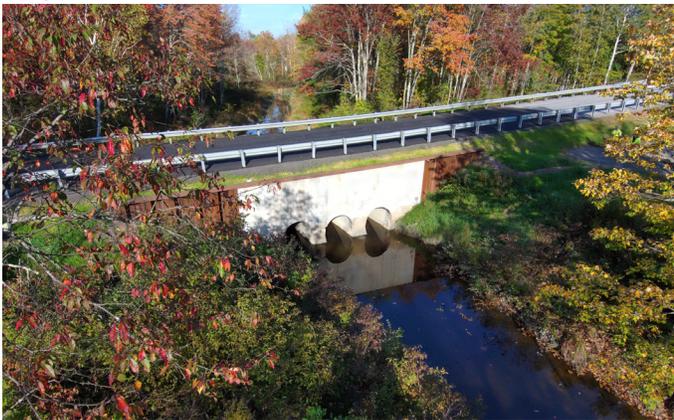
Maxwell Brook Culvert Replacement

Following a major rainfall event in early May 2023, the Town of Sabattus Public Works Department reported a sinkhole within the approach roadway to the Furbush Road Bridge over the Maine Turnpike. An inspection by HNTB concluded one of the three 72" diameter corrugated metal culverts beneath the approach had failed, leading to the erosion of roadway embankment material. The damage necessitated closure of the roadway. Replacement of all three culverts, which are collectively long enough to meet FHWA's definition of a bridge, was recommended. Discussions with the Town and research completed by Maine Turnpike staff concluded ownership of the structure was unclear. Whereas the structure was immediately adjacent to the Turnpike mainline, and the proper functioning of this crossing was critical to MTA operations, the Authority voted to assume responsibility for this structure. Repair plans were developed and replacement of the three culverts was completed in August of 2023.
