PRESENTED TO THE MAINE TURNPIKE AUTHORITY

# OPERATION AND MAINTENANCE ANNUAL REPORT

**2016**

October 1, 2016

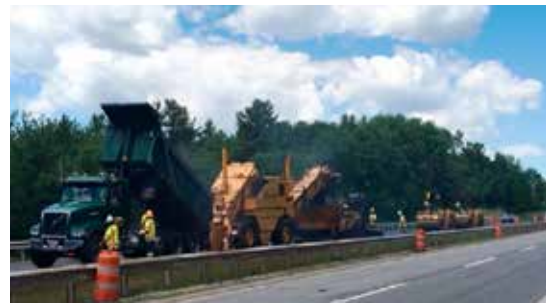
**PAVEMENT REHABILITATION**

Starting in 2014, pavement rehabilitation contracts specified polymer modified asphalt to alter several characteristics of the asphalt, each of which is intended to improve pavement durability, weatherability and performance. This practice continued in 2016. Due to poor condition of the pavement between Mile 54.5 and Mile 57.0 pavement rehabilitation was performed under Contract 2016.01. The rehabilitation work consists of milling and filling the 12-foot wide lanes and the median shoulder. Additional crack repairs were performed before paving back in the milled area. This section was then overlaid full width including shoulders (total of 6.5 inches of new asphalt in places). The rehabilitation also included either shimming and overlaying or milling and filling the two northbound 12-foot wide lanes and shoulders between Mile 59.5 and Mile 64.4 and the two southbound shoulders between Mile 64.4 and Mile 57.0. This contract is currently ongoing.

Due to generally fair conditions of the pavement between Mile 64.4 and Mile 68.5 and between Mile 80.8 and Mile 88.6, and to maintain pavement quality and roadway safety, HNTB recommends the rehabilitation of the northbound and southbound roadway in that area. The rehabilitation should continue the current practice of removing 2” of existing

travel lane pavement, crack sealing, shim, and overlay. These projects should also include repairs to the drainage system such as catch basin repair and repairing pipe outlets.

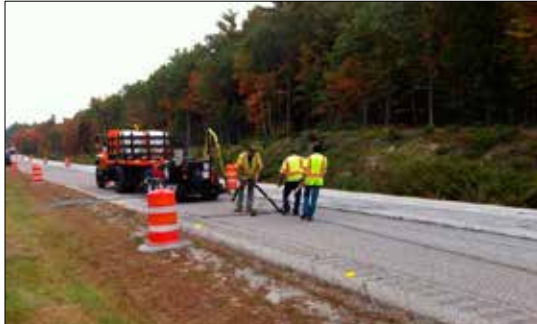
DISPENSED AT OVER 350 DEGREES THE RUBBERIZED ASPHALT SEALANT IS INJECTED DIRECTLY INTO THE PAVEMENT CRACKS

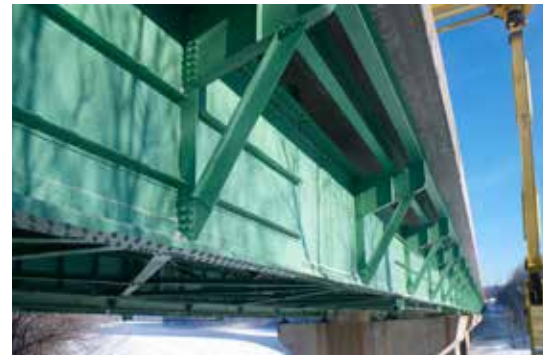
ANDROSCOGGIN RIVER BRIDGE

The Androscoggin River Bridges, each measuring 850 feet long, consist of roadway surfaces supported on stringer and floor beam framing systems. The loads from these roadway framing systems are carried nearly entirely by two primary girders.

Because these structures are carried by only two primary girders, the bridge has insufficient redundancy to prevent a progressive collapse of all, or part of, the bridge if one of the primary girders were to fail. As a result, these structures are classified as “fracture critical” and are subject to more rigorous inspection requirements as outlined in FHWA’s Bridge Inspection Standards. To achieve compliance with these inspection standards, the Androscoggin River Bridges should have a fracture critical inspection completed at least once every 24 months. The last fracture

critical inspection was completed in spring 2015. No significant concerns were identified other than the detachment of the recently constructed wrapping between the post-tensioning tendon sleeve and the anchorage device at several locations. The repair of this condition is warranty work and the Authority is working with the Contractor for its repair. The next fracture critical inspection of this structure should be scheduled for early-2017.

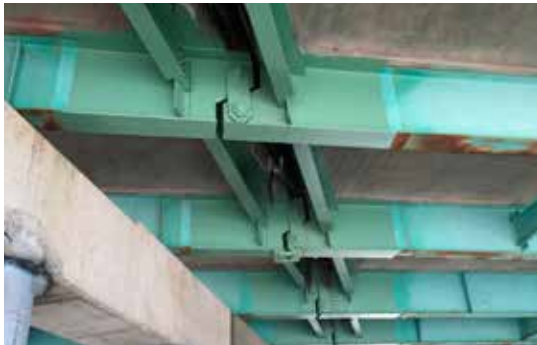
[PIN-AND-LINK ASSEMBLY AT THE YORK RIVER BRIDGE](#)

At the York River Bridges, the girder framing system includes pin-and-link assemblies. Because routine inspection procedures are insufficient to identify defects in the pins, ultrasonic testing of these elements is necessary. A detailed inspection and ultrasonic testing of the pin-and-link systems at the York River Bridges was completed in December 2011. No serious structural deficiencies were noted during that inspection. The next detailed inspection of the pin-and-link assemblies was scheduled for 2016, however, a 2015 rehabilitation contract involved disassembling, reassembling, and painting the pin-and-links. This was justified as an acceptable detailed inspection procedure and ultrasonic testing was not performed. The next detailed inspection including ultrasonic testing should be scheduled for summer 2020.

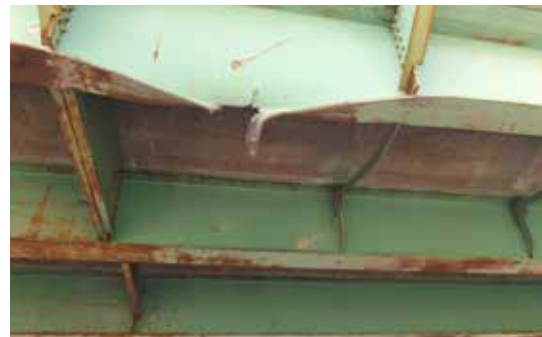
[EXIT 45 UNDERPASS, MILE 44.9](#)

The Exit 45 Underpass at Mile 44.9 was struck by an overheight vehicle on June 14, 2016. HNTB conducted a special inspection and made a recommendation to the Authority for the repair of the significant impact damage. Part of that recommendation included temporarily restricting traffic with drums to avoid overstressing the damaged girder.

The Exit 45 Underpass at Mile 44.9 was struck by an overheight vehicle on June 14, 2016. HNTB conducted a special inspection and made a recommendation to the Authority for the repair of the significant impact damage. The damage will be repaired by solicitation in fall 2016.

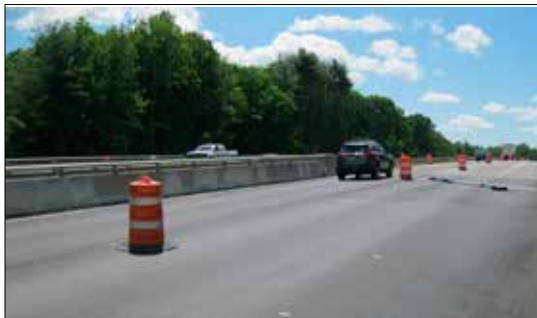
HUNTS HILL ROAD OVERPASS, MILE 61.6

The work includes substructure repairs and the removal and replacement of the bituminous overlay and waterproof membrane, and deck repairs, performed as part of the pavement rehabilitation contract.

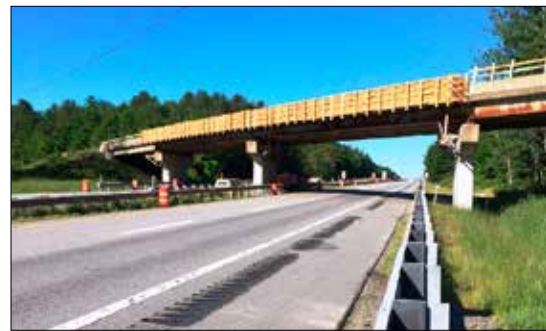
SMALL ROAD UNDERPASS, MILE 95.1

The work includes the removal and replacement of the bridge superstructure (steel beams and concrete deck), and substructure repairs. In addition, the work includes raising the bridge to increase the vertical clearance to minimize the potential for damage from an overheight vehicle.

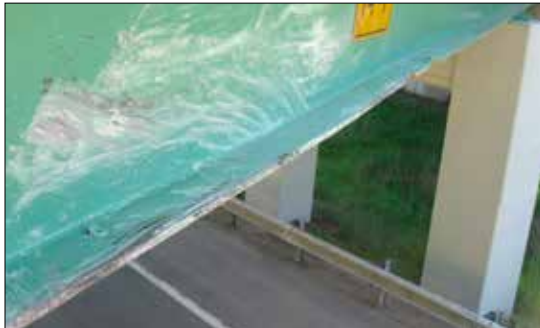
RAMP M BRIDGE, MILE 1.7

The Ramp M Bridge at Mile 1.7 was struck by an overheight vehicle on May 27, 2015. HNTB conducted a special inspection and made recommendations to the Authority for the repair of the minor impact damage. The damage was repaired by the Authority Maintenance forces.

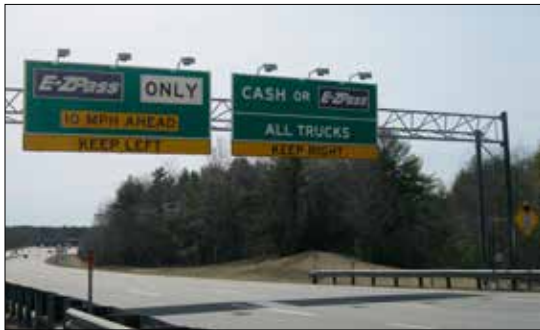
OVERHEAD SIGN BRIDGE MAINLINE SB, MILE 7.8

The Authority is responsible for 75 sign structures, with structure types that include overhead sign bridges, mast-arms, space frames, VMS on butterfly supports, and bridge-mounted signs. These structures carry regulatory, route marker, warning, and specialty signage. Routine or ground inspection of the Authority's sign structures is conducted yearly as part of the routine bridge inspection and no significant issues have been observed.

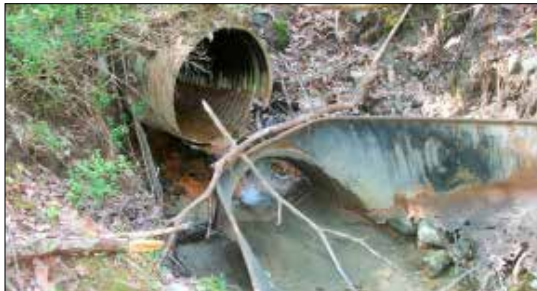
These pipes were found to be in good to poor condition. Many of the cross-culverts are reinforced concrete under the core roadway but change to metal under the side slopes. While the concrete portion of the culverts are generally in fair to good condition, many of the metal pipe ends are in poor condition. Common issues observed are rusted flow lines, disconnected joints, and disconnected metal flared end sections. These conditions lead to erosion issues on the side slope which may eventually impact the roadway.

Periodically the Authority issues contracts to repair drainage issues that the Authority's Maintenance forces cannot repair due to their location or the type of equipment required to

cost effectively complete the repair.

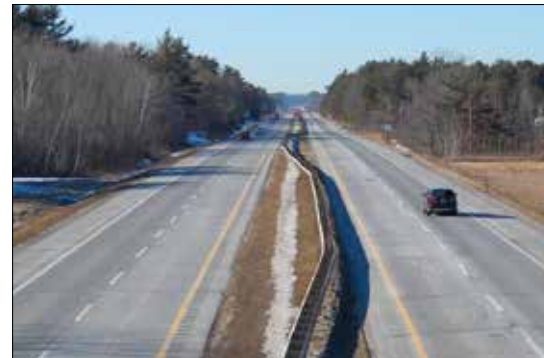
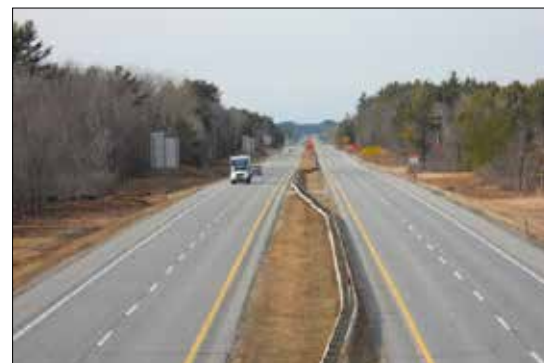
ROADWAY SIDE SLOPE CLEARING LOOKING SOUTH, MILE 102 (BEFORE)

ROADWAY SIDE SLOPE CLEARING LOOKING SOUTH, MILE 102 (AFTER)

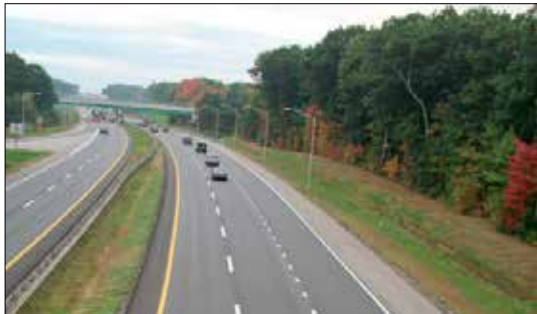
The Authority is also utilizing reflectorized pavement marking tape installed in grooves at interchange ramps and to supplement the white skip lines on the mainline. The tape improves visibility of the pavement markings in wet conditions.

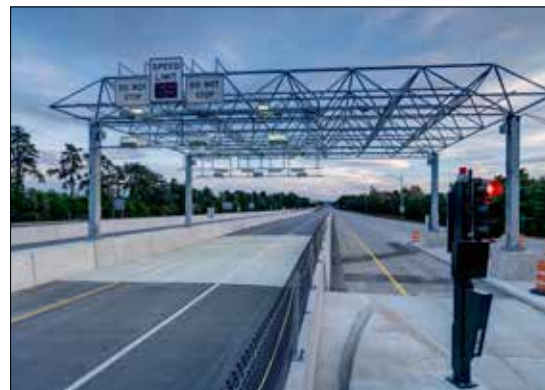
NEW GLOUCESTER TOLL PLAZA ORT, MILE 67.0

- Provides programmed system enhancements for violation enforcement in staffed lanes, video audit, and reduces maintenance costs.
- Use of loops embedded in concrete slabs for vehicle classification eliminates the maintenance concern of treadles.

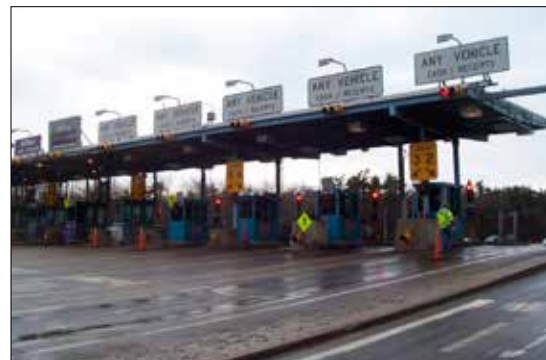
EXISTING YORK TOLL PLAZA - CONSTRUCTED IN 1969

The existing York Toll Plaza was constructed in 1969 and is challenged by both operational and safety issues and the existing toll system has reached the end of its useful life. The plaza is rated in fair to poor condition.

Considering the condition of the York Toll Plaza, decisions relating to the replacement of the toll system should consider the practicality of installing the toll system in the deficient infrastructure, or whether the infrastructure should be upgraded at the existing location, or an alternate location selected for a new plaza.
