Maine Turnpike Authority

2016 Annual Inspection

**Maine Turnpike Annual Inspection
2016**

Inspection Field Report
Prepared by: HNTB Corporation

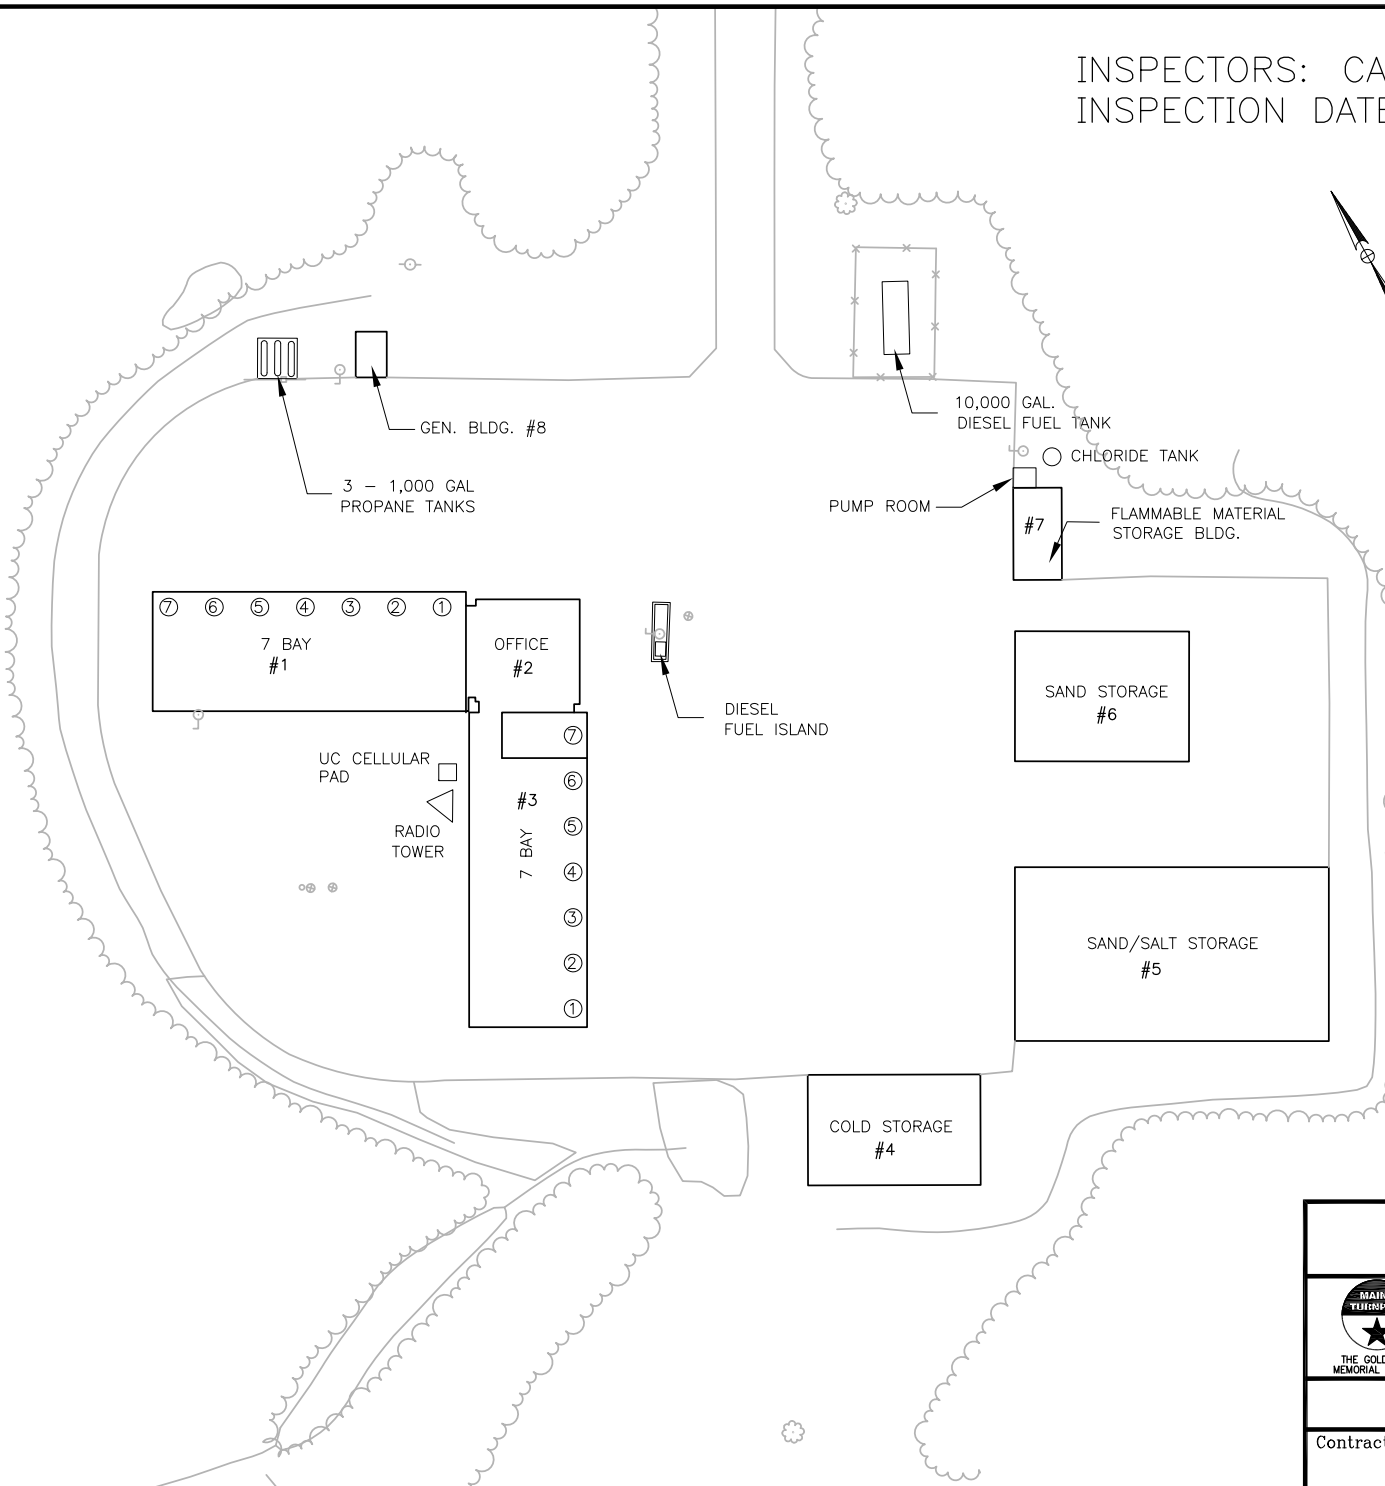
Maine Turnpike Authority Maine Turnpike	
	SITE PLAN MILE 6.8 YORK MAINTENANCE AREA
	HNTB Engineers Architects Planners
Contract 2016	Sheet No. 1 of 1

2: Cracks in the floor. Floor damp near louver.

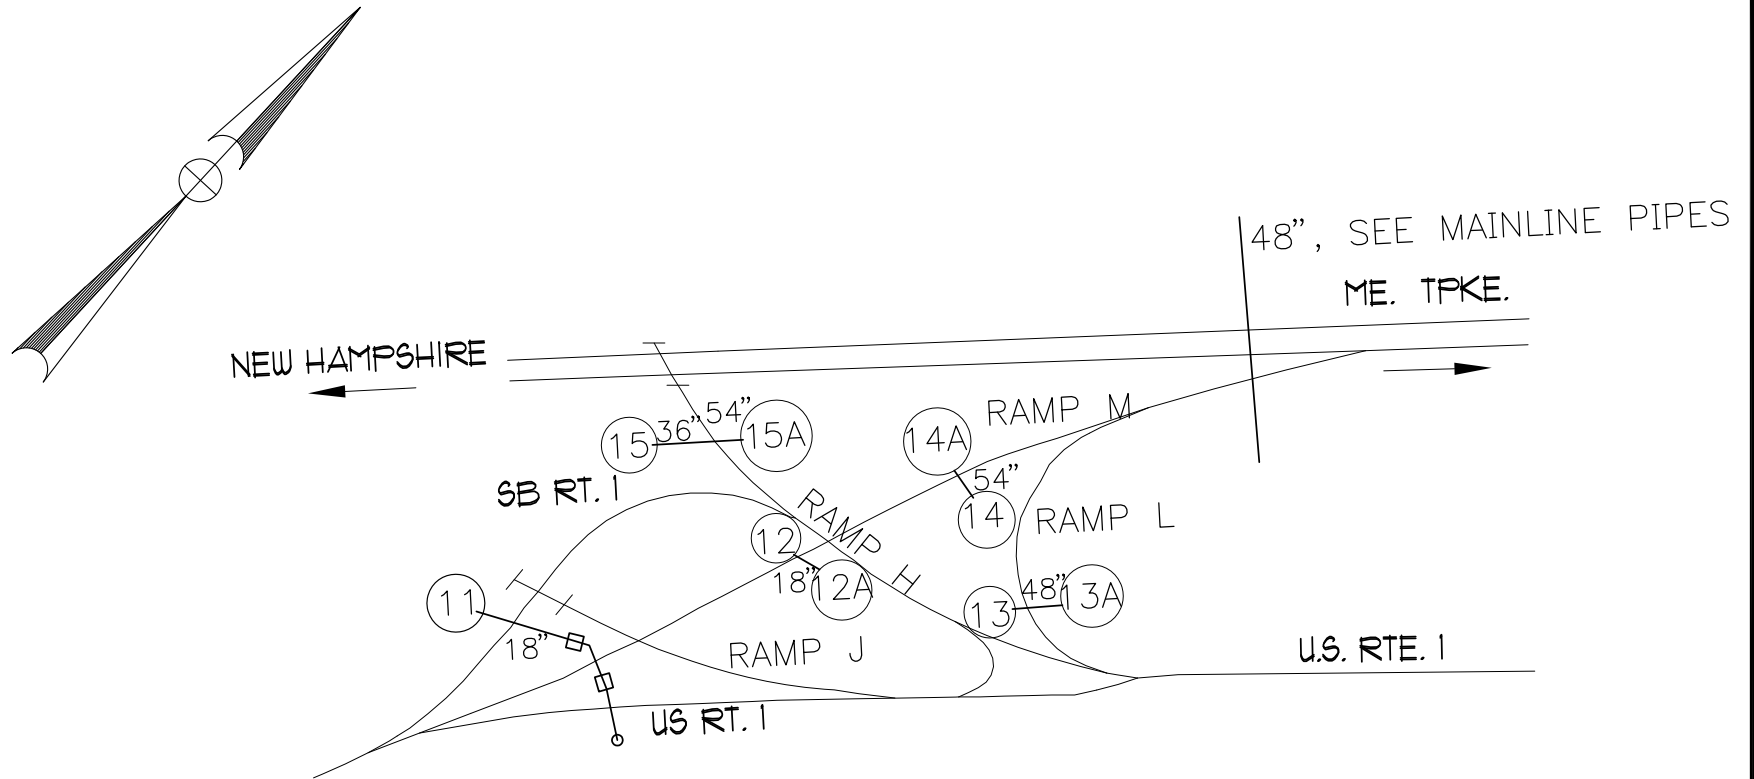
Maine Turnpike Authority Maine Turnpike	
	INTERCHANGE PIPE CULVERTS ROUTE 1 KITTERY EXIT 3
	HNTB Engineers Architects Planners
Contract 2016	Sheet No. 1 of 1

Exposed reinforcement on pipe rim. Outlet from DI.

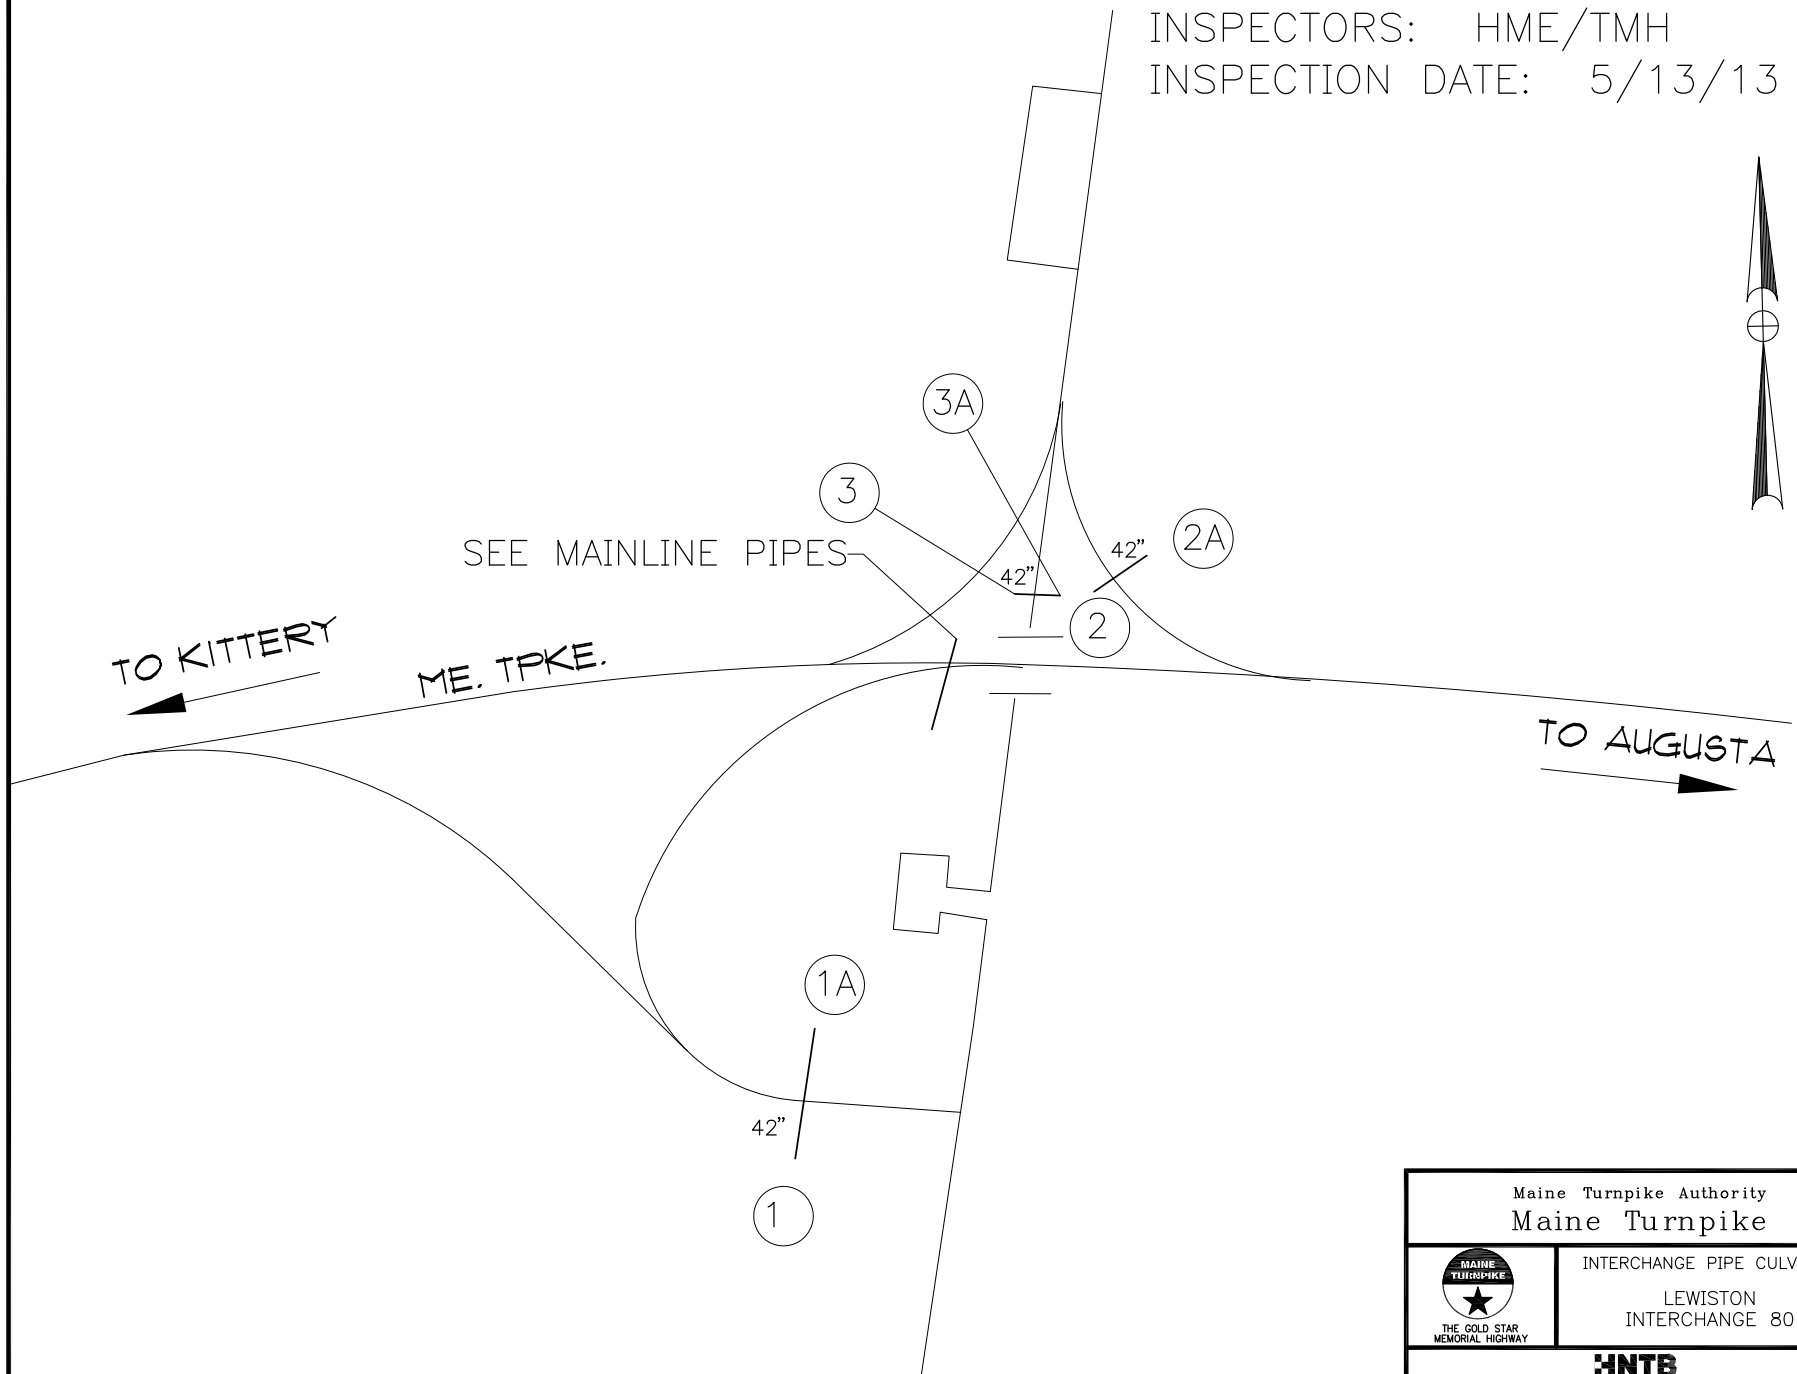
Pipe invert completely deteriorated and overgrown with vegetation.
