Exit 75 Transportation Study

Phase I Report

Short Term Transportation Needs

Maine Turnpike Authority

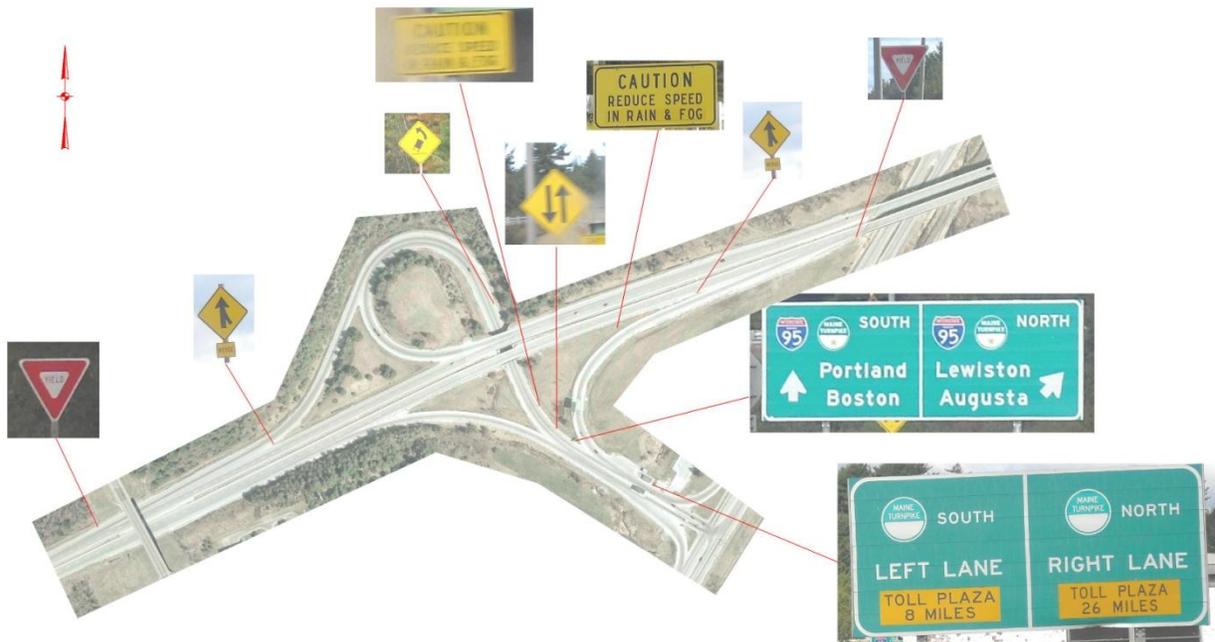
Figure 13 - Exit 75 on-ramps signing

A diagram of the Exit 75 on-ramp signing is shown in Figure 13, which includes the regulatory, warning, and guide signs. The regulatory and warning signs on the on-ramps are generally appropriate and convey a clear message. Unlike the off-ramp signing, the guide signs for the on-ramps do effectively convey directions to the motorist.

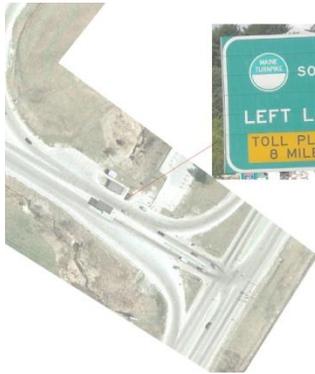
Figure 14 - Guide signs at beginning of weave section

Even though the sign at the beginning of the weave section (see Figure 14) displays a slightly different message than the guide sign at the split for northbound and southbound traffic (see

Figure 15), the message displayed is not confusing, and the placement of the signs is appropriate. During trips to the field, HNTB noted that these guide signs were highly visible and provided timely information. Therefore, upgrades to the guide signs at the weave section shown in Figure 14 and Figure 15 are not necessary, and mounting these signs at an overhead location is not warranted.

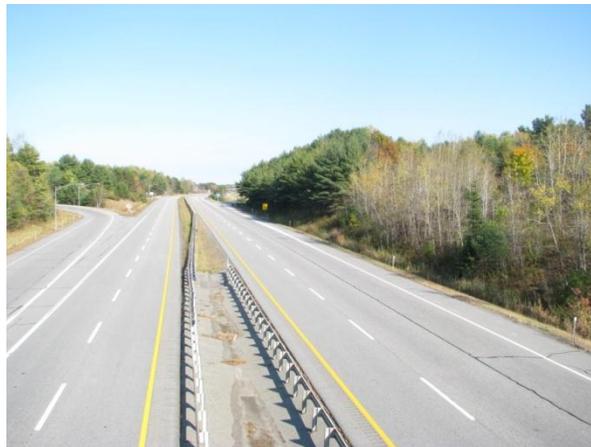
Figure 18 – Mainline of Maine Turnpike looking NB from the Kitty Hawk Ave. overpass

The 2009 MTA Annual Inspection was referenced in order to rate the section of Maine Turnpike mainline two miles before and after the Exit 75. The NB mainline segment of the turnpike received a “generally good condition” rating and the SB mainline received a “good condition” rating. The field visit on October 20, 2009 confirmed this year’s inspection results. Only minor rutting (<1/4”) has occurred in this four mile segment. Transverse and longitudinal cracking were observed throughout this corridor, but not significant enough to warrant any repair/maintenance action. This section of the Maine Turnpike was repaved in 2006. No additional paving is recommended for this section of the Turnpike.

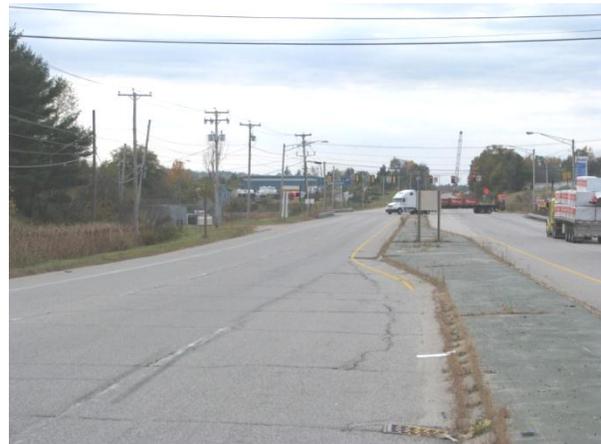
Figure 24 – Looking south toward the intersection with Kitty Hawk Ave.

degradation in the median between the NB and SB Route 202/4/100 traffic. The double crown for both directions of Route 202/4/100 causes turning heavy vehicles to bounce even at moderate speeds (see Figure 23). Another issue at the intersection is the northbound left turn lane from Route 202/4/100 onto the Turnpike (see Figure 24). There is noticeable pavement shoving, rutting and cracking throughout this lane making the turning movement slow and difficult which is due in part to the “bouncing” vehicles as well as the constant stopping, queuing, and starting movements typically experienced at intersections.

Improvements recommended for Route 202/4/100 are a pavement overlay and re-striping from the Maine Turnpike Overpass to Kittyhawk Ave. MaineDOT should consider extending the limits of an overlay through the entire section of focused study area on Route 202/4/100.

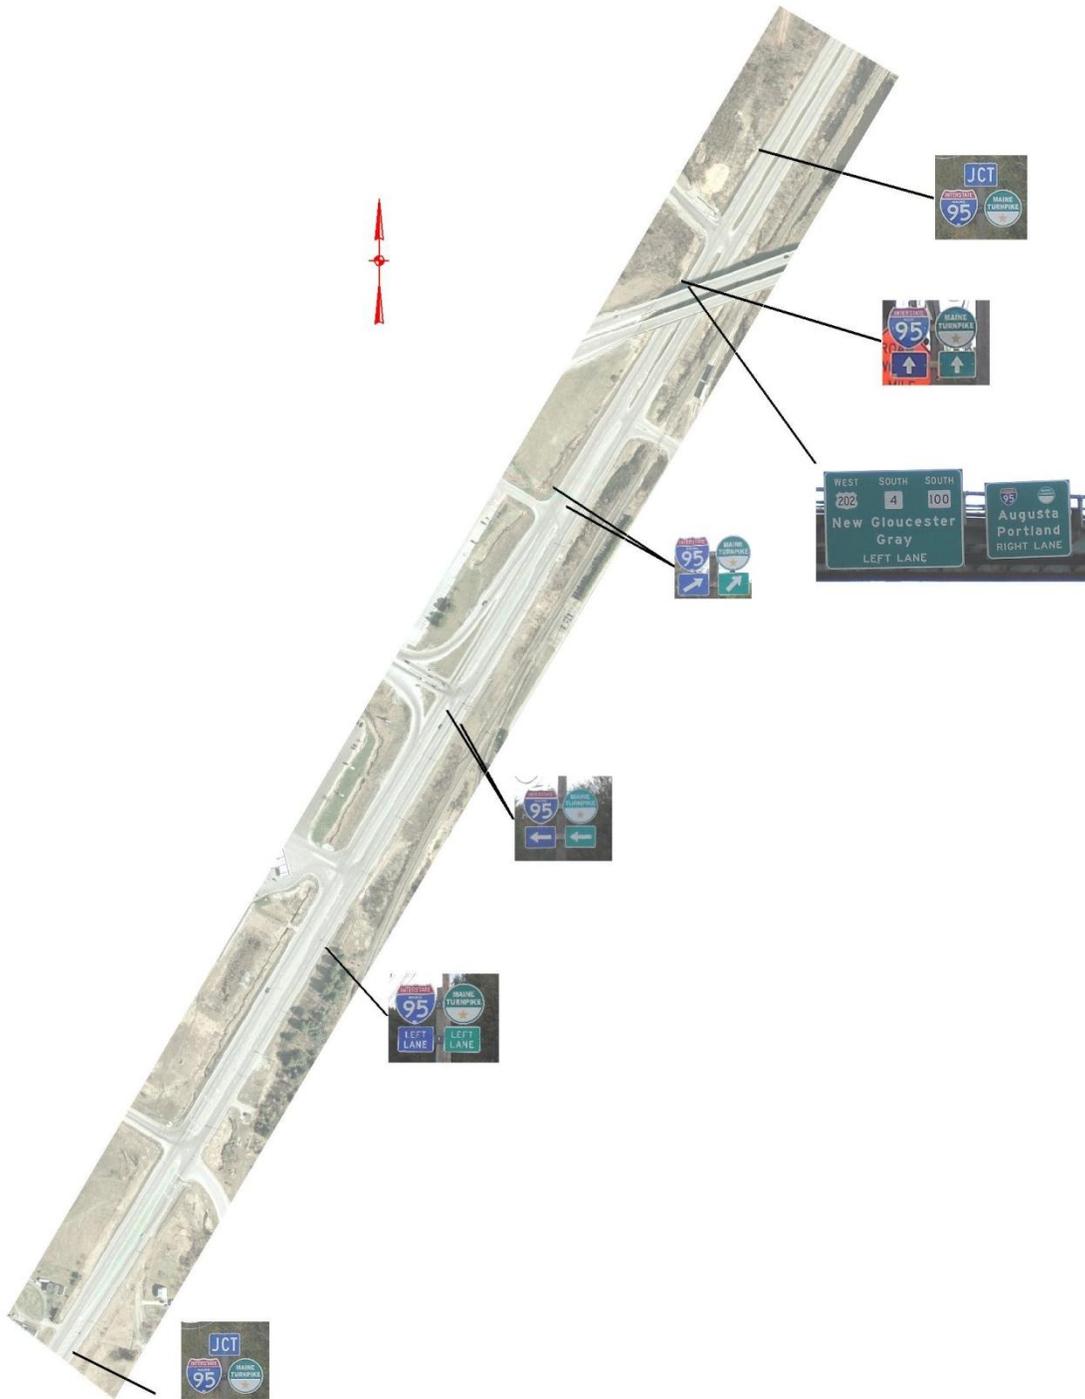
Figure 25 - Route 202/4/100 Signing

A diagram of the Route 202/4/100 guide signing is shown in Figure 25. The guide signs and trailblazers on Route 202/4/100 for traffic heading southbound are compliant with the MUTCD. The southbound signing gives appropriate signing at appropriate locations to guide motorists to the Turnpike on ramps. The signing for northbound traffic, however, is not in compliance with the guidelines of the MUTCD. The MUTCD strongly recommends that an advance entrance direction sign (see Figure 26 for an example of this sign that is placed in the southbound direction) be placed on multi-lane conventional roads approaching an interchange. An advance entrance direction sign will better guide northbound traffic to the Turnpike.
