2022 OPERATION AND MAINTENANCE ANNUAL REPORT

PRESENTED BY: HNTB CORPORATION PRESENTED TO: MAINE TURNPIKE AUTHORITY

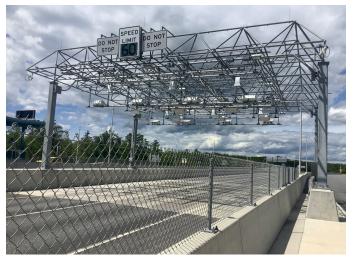
WEST GARDINER BARRIER TOLL PLAZA ORT LANE

Construction of the new West Gardiner I-295 Mainline Toll Plaza, and removal of the existing plaza, was completed in November 2021. The new facility consists of two ORT lanes and three cash lanes in each direction and operates using the new Infinity Toll System.
