September 14, 2020

SUBJECT: Maine Turnpike Authority
Stormwater Program Management Plan
Maine DEP Permit # MER043001
Annual Report for Permit Year Seven (July 1, 2019 through June 30, 2020)

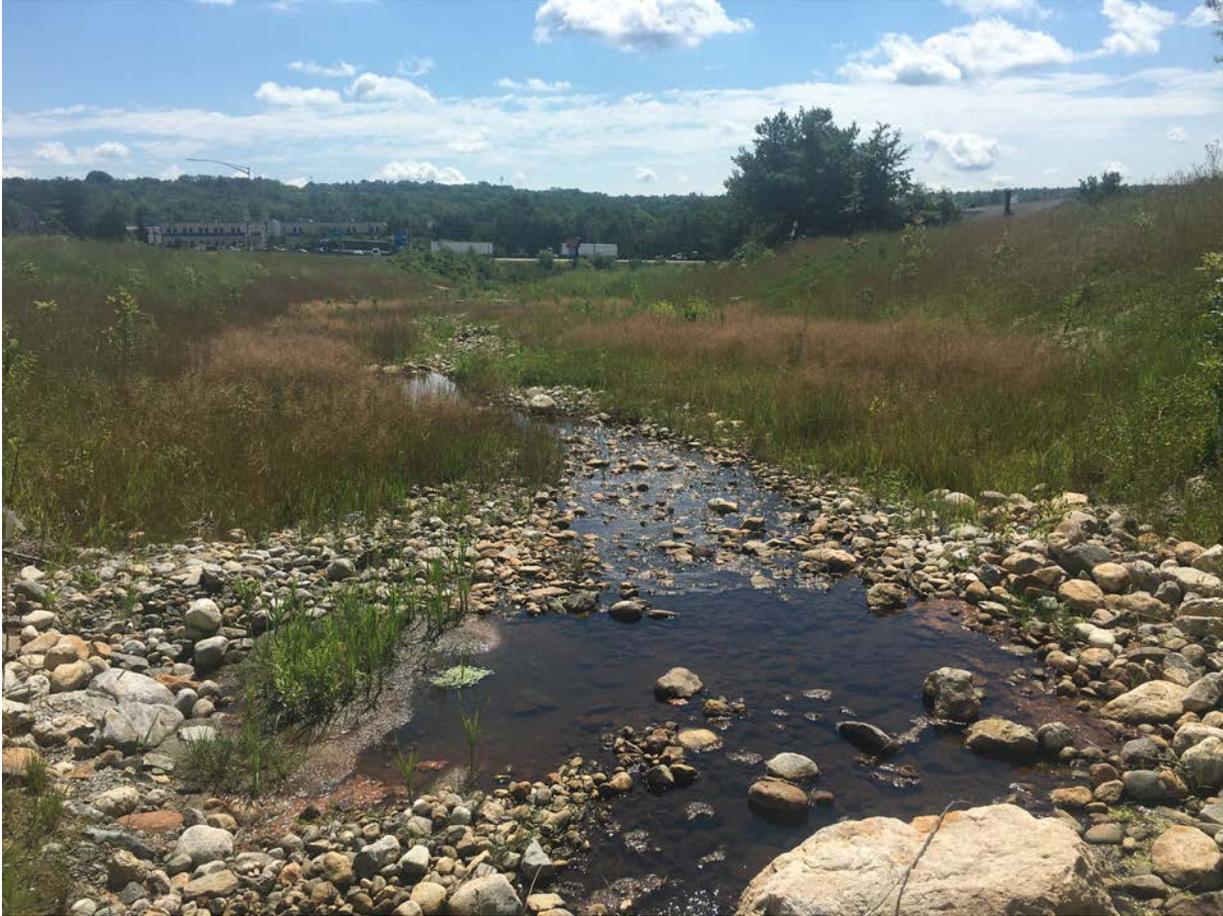
Photograph 1 – July 2020 photograph of relocated and restored segment of an unnamed tributary to Moose Brook within the UA boundary in the first growing season following construction at Exit 75 in Auburn. Photo direction is facing downstream.

In addition to the post-construction stormwater treatment BMPs outlined in Table 1, as part of contract 2018.17 Exit 75 Toll System Slope Repair Project, MTA also restored approximately 629 linear feet of an unnamed perennial tributary to Moose Brook and associated riparian zone located within the UA at Exit 75 in Auburn. The stream channel had been previously realigned into a ditch configuration at the base of the Exit 75 northbound off ramp, where the ramp slopes were beginning to erode and become unstable. As part of this ramp slope stabilization project, MTA relocated the stream and restored in-stream and riparian habitat following a natural channel design with pools, riffles, a gravel and cobble substrate, and a riparian zone with shrub and sapling plantings. Photograph 1 below shows the relocated stream channel and constructed riparian zone in the first growing season following construction. Within one year of the completion of construction, fish and crayfish were observed in the restored stream channel, and additional wildlife were inhabiting the restored riparian zone.
