SUBJECT: Maine Turnpike Authority  
Stormwater Program Management Plan  
Maine DEP Permit # MER043001  
Annual Report for Permit Year Eight (July 1, 2020 through June 30, 2021)

This Annual Report describes the status of MTA's Best Management Practices (BMPs) and Measurable Goals (MGs) program for each of the six Minimum Control Measures (MCMs) presented in MTA's Stormwater Program Management Plan (SPMP) (dated December 2, 2013) for PY8.

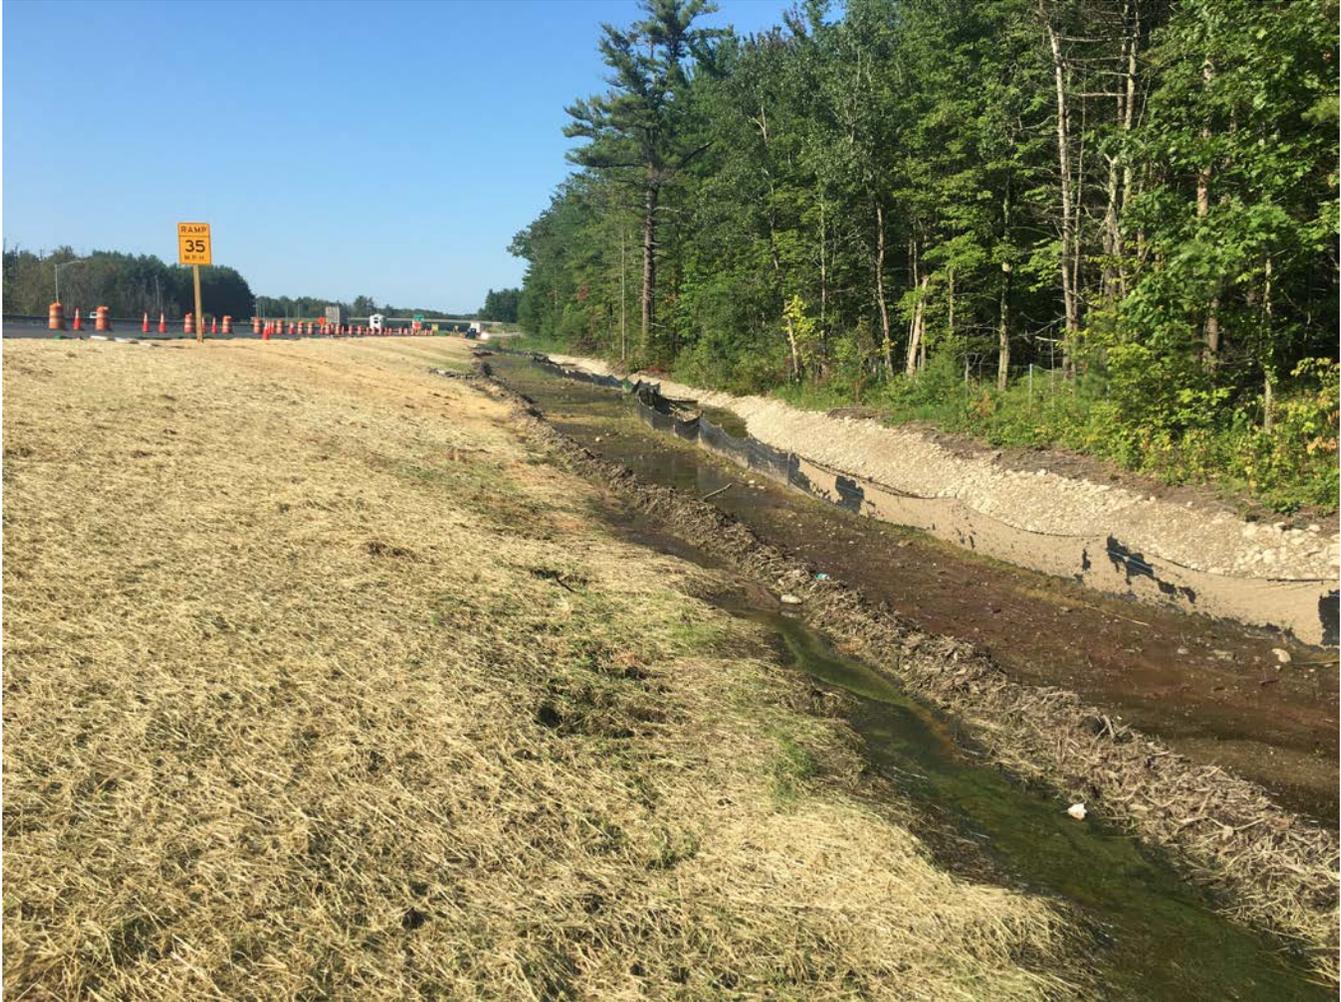
**Photograph 1 – August 2021 photograph of relocated stream and re-constructed riparian wetlands along an unnamed tributary to Thatcher Brook within the UA boundary in Biddeford at Exit 32 southbound.**

**The stream is behind the silt fence, and the site had not yet revegetated at the time of the photo. The stream was moved out of the former ditchline and located further from the road with meanders and four log features embedded in the stream bottom. The area between the toe of the highway slope and the stream has been seeded with a wetland seed mix and will not be mowed. Photo direction is facing upstream.**

In addition to the post-construction stormwater treatment BMPs outlined in Table 1, as part of contract 2021.01 Pavement Rehabilitation and Safety Improvements Project, in 2021 MTA relocated 490 linear feet of an unnamed tributary to Thatcher Brook to accommodate Exit 32 ramp improvements. The project design included moving the stream as far from the southbound lanes of the Turnpike as feasible with natural meanders and in-stream wood additions, while remaining within MTA right-of-way. The end result was an overall increase in the distance between the channel and the southbound lanes, including a 121-foot segment of channel that had been previously straightened and routed into the road ditch. The Thatcher Brook watershed-based plan identifies this location as an area with poor buffering, which will be improved by relocating the channel further from the roadway and maintaining a riparian wetland fringe when the site revegetates. One of the goals of the relocation was to improve opportunity for infiltration and sheet flow of runoff from the outside lane of the Turnpike between the edge of the pavement and the stream. Photograph 1 below shows the relocated stream channel and re-constructed riparian zone during construction before the site had revegetated. Fish and crayfish have been observed in the relocated stream channel.
